FIRST FLOOR PLAN

SECOND FLOOR PLAN

THIRD FLOOR PLAN

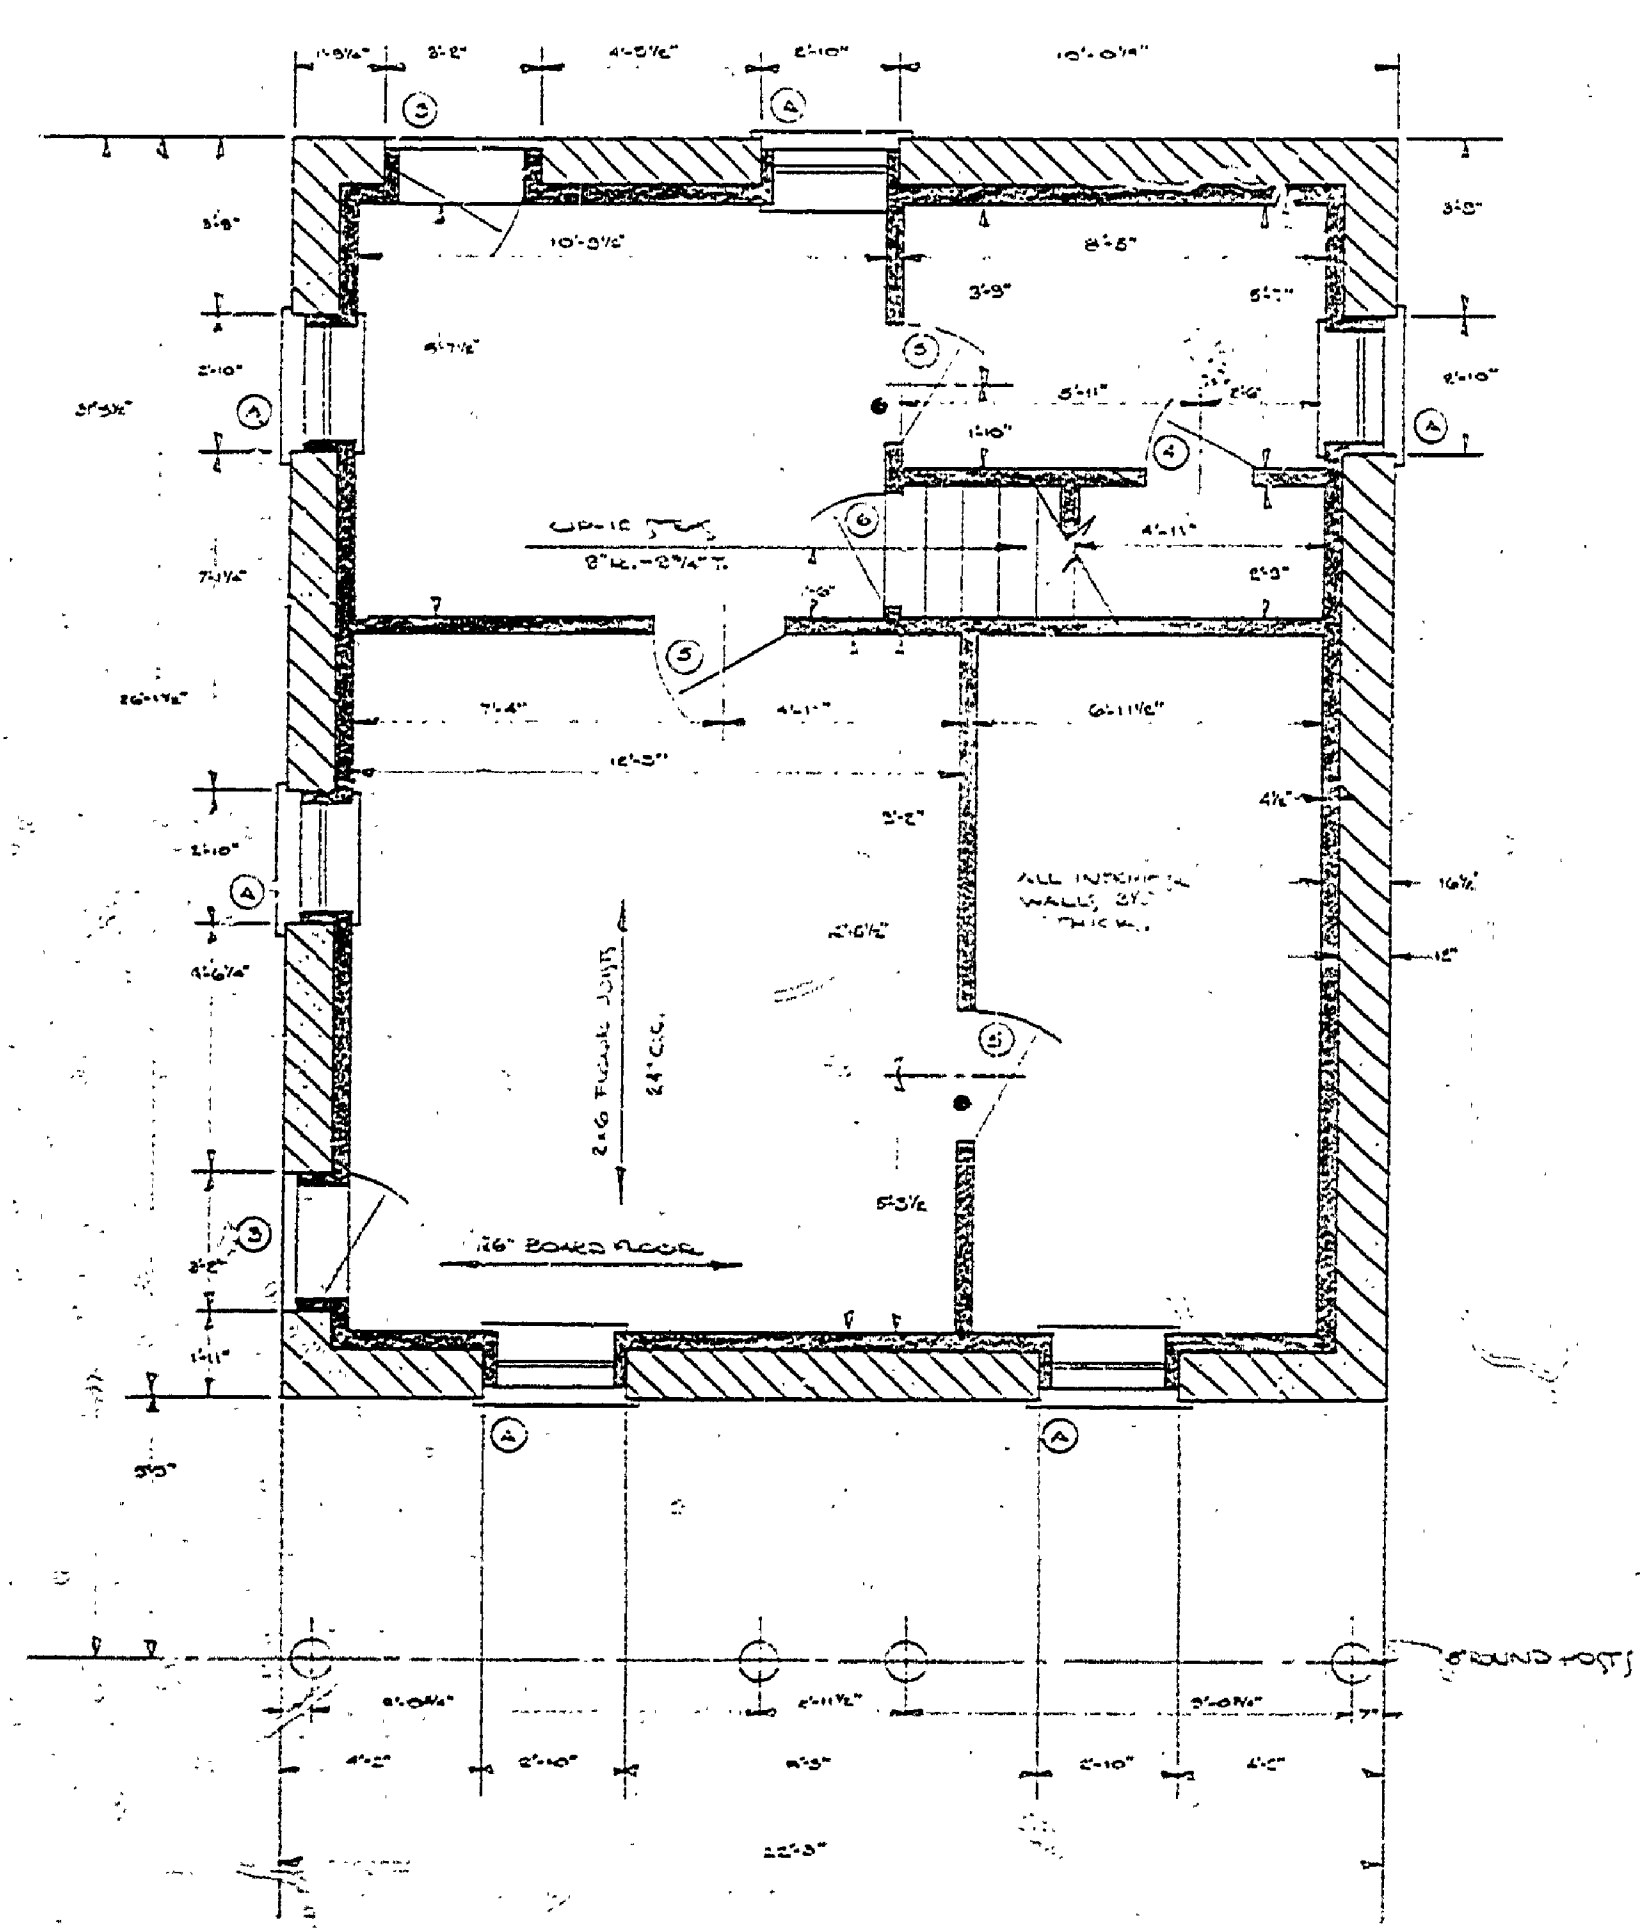
NOTE:  
 ALL FLOORS INDICATED WITH SMALL "DOT" ARE MISSING.  
 FLOORING THROUGHOUT HOUSE IS IN POOR CONDITION.  
 FRONT STEPS TO PORCH ARE IN EXTREMELY DANGEROUS CONDITION.  
 FRONT PORCH AS SHOWN WAS NOT AN ORIGINAL HOME.  
 REAR PORCH IS MISSING.  
 SAFETY RAIL AROUND TOWER WELL IS MISSING.  
 SASHES IS NOT ORIGINAL.  
 PLASTER IN THIS AREA IS MISSING AND HAS BEEN REPLACED WITH FIBERBOARD. IT IS NOW IN POOR CONDITION.
