SITE OF CAMP LUDINGTON-PERE MARQUETTE

X-SECTION THROUGH DAM
SCALE 1" = 10'

DEPARTMENT OF THE INTERIOR NATIONAL PARK SERVICE And MICHIGAN DEPARTMENT OF CONSERVATION CO-OPERATING				E-87	
BRANCH OF PLANNING		STATE PARK DIVISION			
SYMBOL		NUMBER	122	SHEET NO.	2
DRAWN BY		LUDINGTON STATE PARK SP-2 DAMS IM-POUNDING-REPAIRS		FILE NO.	
		SCALE 1" = 50'			
CHECKED		DESIGNED			
DATE		PROJECT SUPERINTENDENT	DATE		
RECOMMENDED FOR CONSTRUCTION		DATE	12/4 35		
DATE		FIFTH REGIONAL INSPECTOR	DATE		
APPROVED FOR CONSTRUCTION	6/23/32	APPROVED		SUPV. OF STATE PARKS	
DATE		FIFTH REGIONAL OFFICE S.P.S.	DATE	MICH. CONSERVATION COMM.

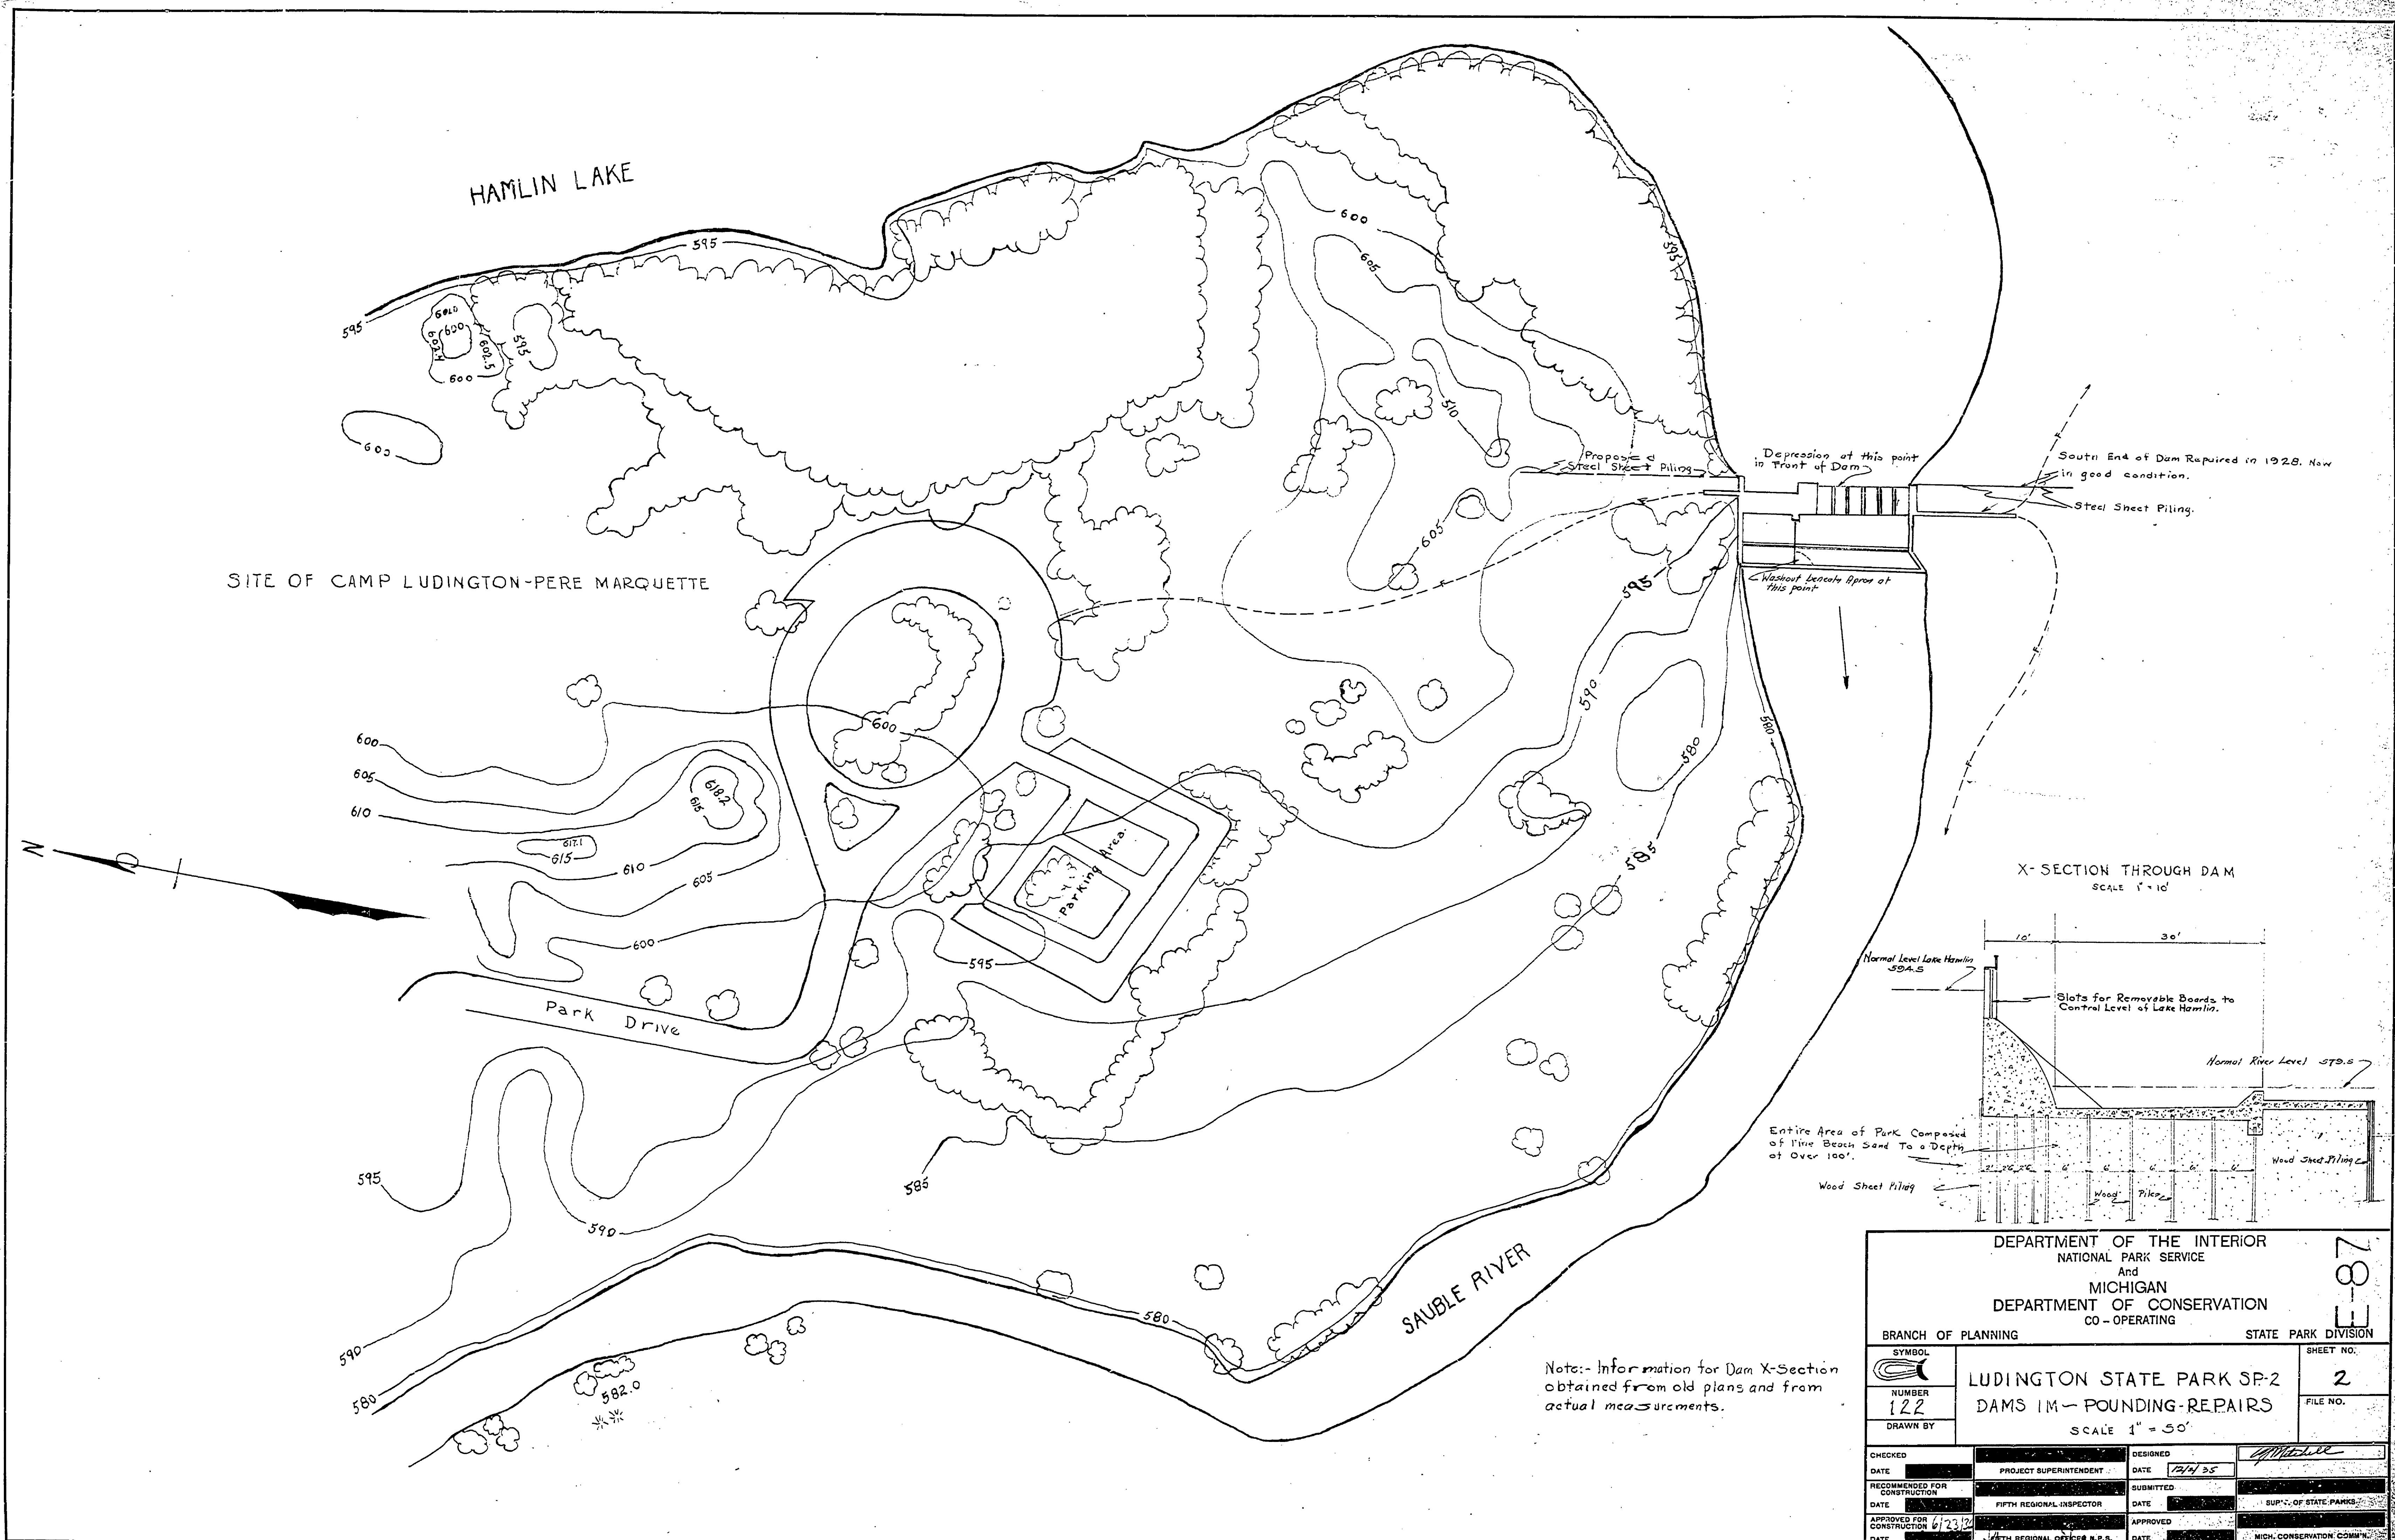
Proposed Steel Sheet Piling
Depression at this point in front of Dam
Steel Sheet Piling
South End of Dam Repaired in 1928. Now in good condition.

Without concrete apron at this point

Entire Area of Park Composed of Fine Beach Sand to a Depth of Over 100'.
Wood Sheet Piling
