LAND CORNER RECORDATION CERTIFICATE
Filing Requirement of Act 74, Mich. PA 1970

Form with fields for Lake (County), Located In, Corner Code #, and numbered sections 1-5 for survey details and private claims.

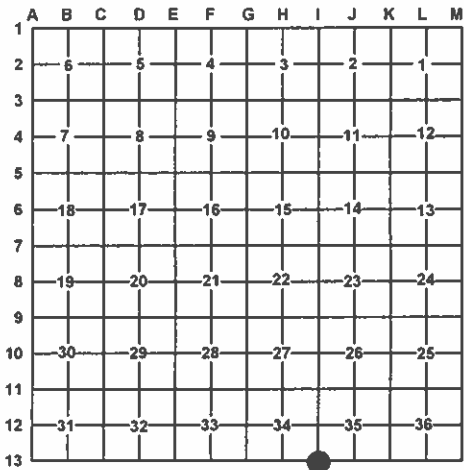
I-13 - Standard corner common to Sections 34 & 35, T19N, R12W - Fd. broken Dept. of Conservation (DOC) alum. cap on bent over 1" x 36" long galv. iron pipe. No GLO evidence. Witnesses #3 & #4 are stumps, witness #5 is OK but had broken cap. Replaced broken & bent DOC monument with DNR monument at record distance from 'I-1', T18N, R12W on standard line. DNR monument accepted as a careful & faithful reestablishment of the position of the original corner.

I-13 - Stamped 4" DNR aluminum cap on 1" x 36" long galv. iron pipe.
Set Blue Composite Post 1' North.
East 30.23' to I1, T18N, R12W - DNR monument (Replaced Broken DOC Mon.)
N5°E 11.20' to set nail & tag in W side 2" R Maple
S11°W 16.81' to set nail & tag in W side 5" R Maple scribed 'XBT'
S36°E 38.97' to set nail & tag in NE side tw. 4" R Maple
