Dowagiac River - Pucker Street Dam Draw Down Experience

Berrien County, T07S, R17W, Secs 12, 13, 14, 22, and 23

Surveyed May 1999 through September 2002

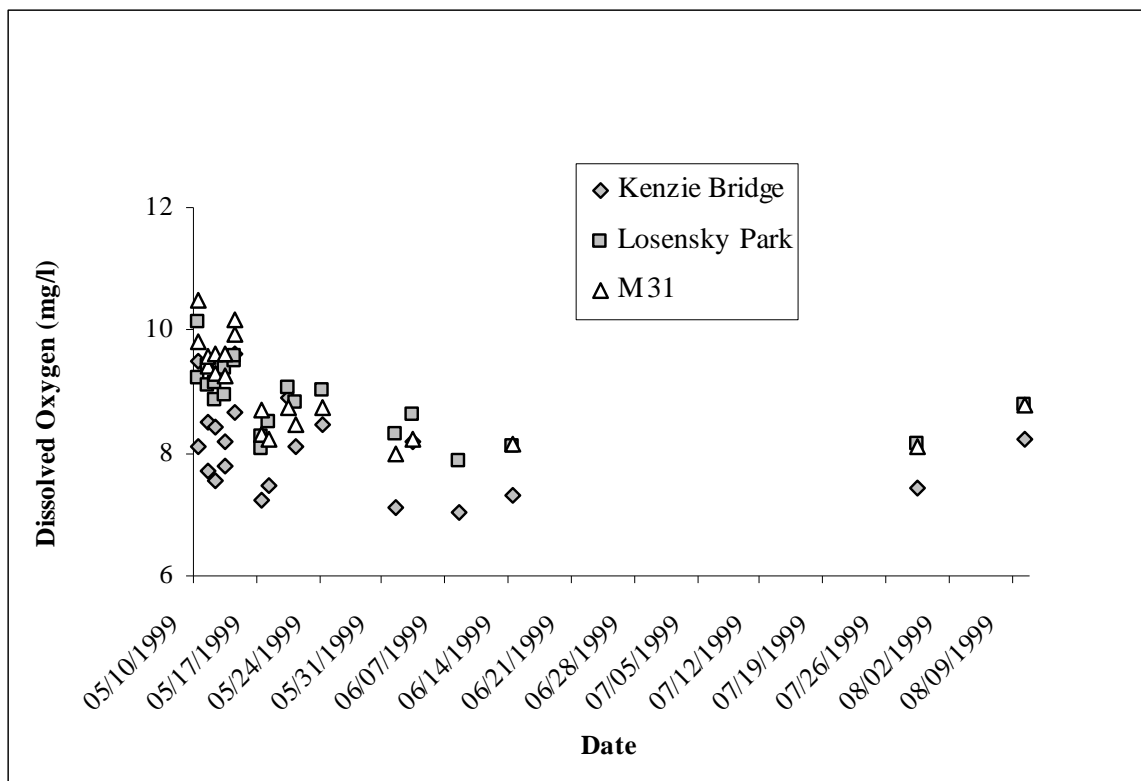
Figure 5. Dissolved oxygen of the Dowagiac River during the Pucker Street Dam drawdown.

Dissolved oxygen remained high throughout the drawdown (Figure 5). Oxygen was highest when river temperatures were lower. Losensky Park and M-31 monitoring sites had higher dissolved oxygen concentrations than the Kenzie Road site, which was probably due to atmospheric mixing of air and water going over the dam and riffles in the lower river.

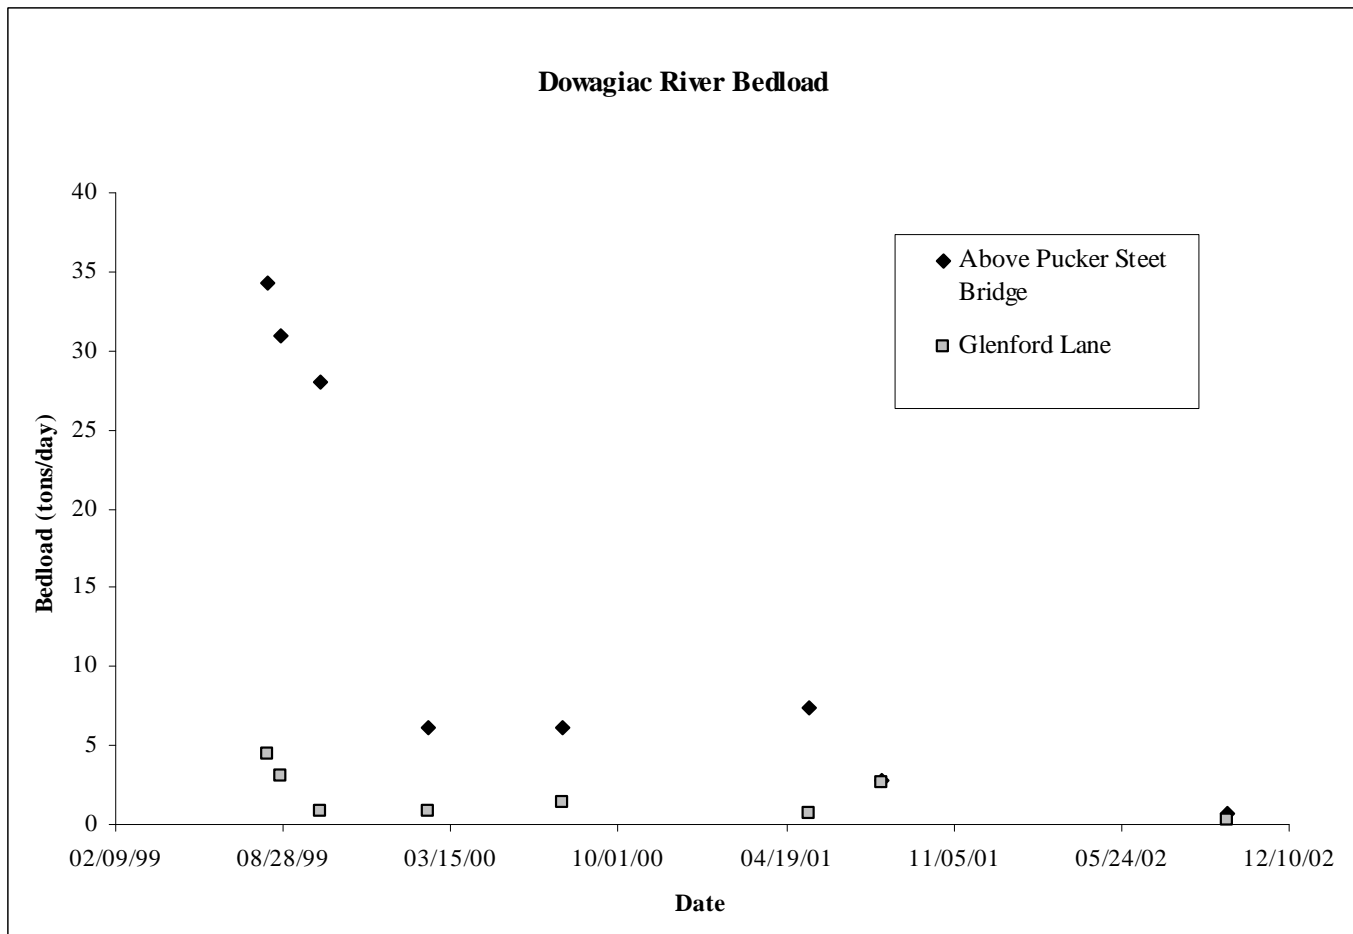
Figure 7. Dowagiac River bedload above Pucker Street Bridge and Glenford Lane.

Bedload estimates were 35 tons per day when the trap was first installed while estimates at Glenford Lane ranged from five to less than one ton per day depending on river discharge (Figure 7). The bedload above Pucker Street Bridge remained high through the fall of 1999. From spring of 2000 through spring of 2001, the bedload above the dam remained at about five tons per day. In the fall of 2001, the bedload estimates above the Pucker Street bridge and Glenford Lane were approximately the same at 3 tons per day. At this time, trap cleaning frequency was down to about once every 6 months. The bedload estimates were again the same in September 2002 at less than one ton per day. At this time, the City of Niles and Fisheries Division officially abandoned the trap. The mountain of sand that was created with the sand spoils was leveled, top soiled, and seeded (Appendix 1, Pg 7).

Bedload estimates to monitor sediment movement through the impoundment were useful. It would have been difficult otherwise to determine when sand bedloads were back to natural levels. The method used was only appropriate to determine the difference in bedload between sites and may not have accurately estimated the actual bedload of the Dowagiac River. A Helley-Smith sampler and methods described by Beschta (1996) would provide better estimates for comparison with other river systems.

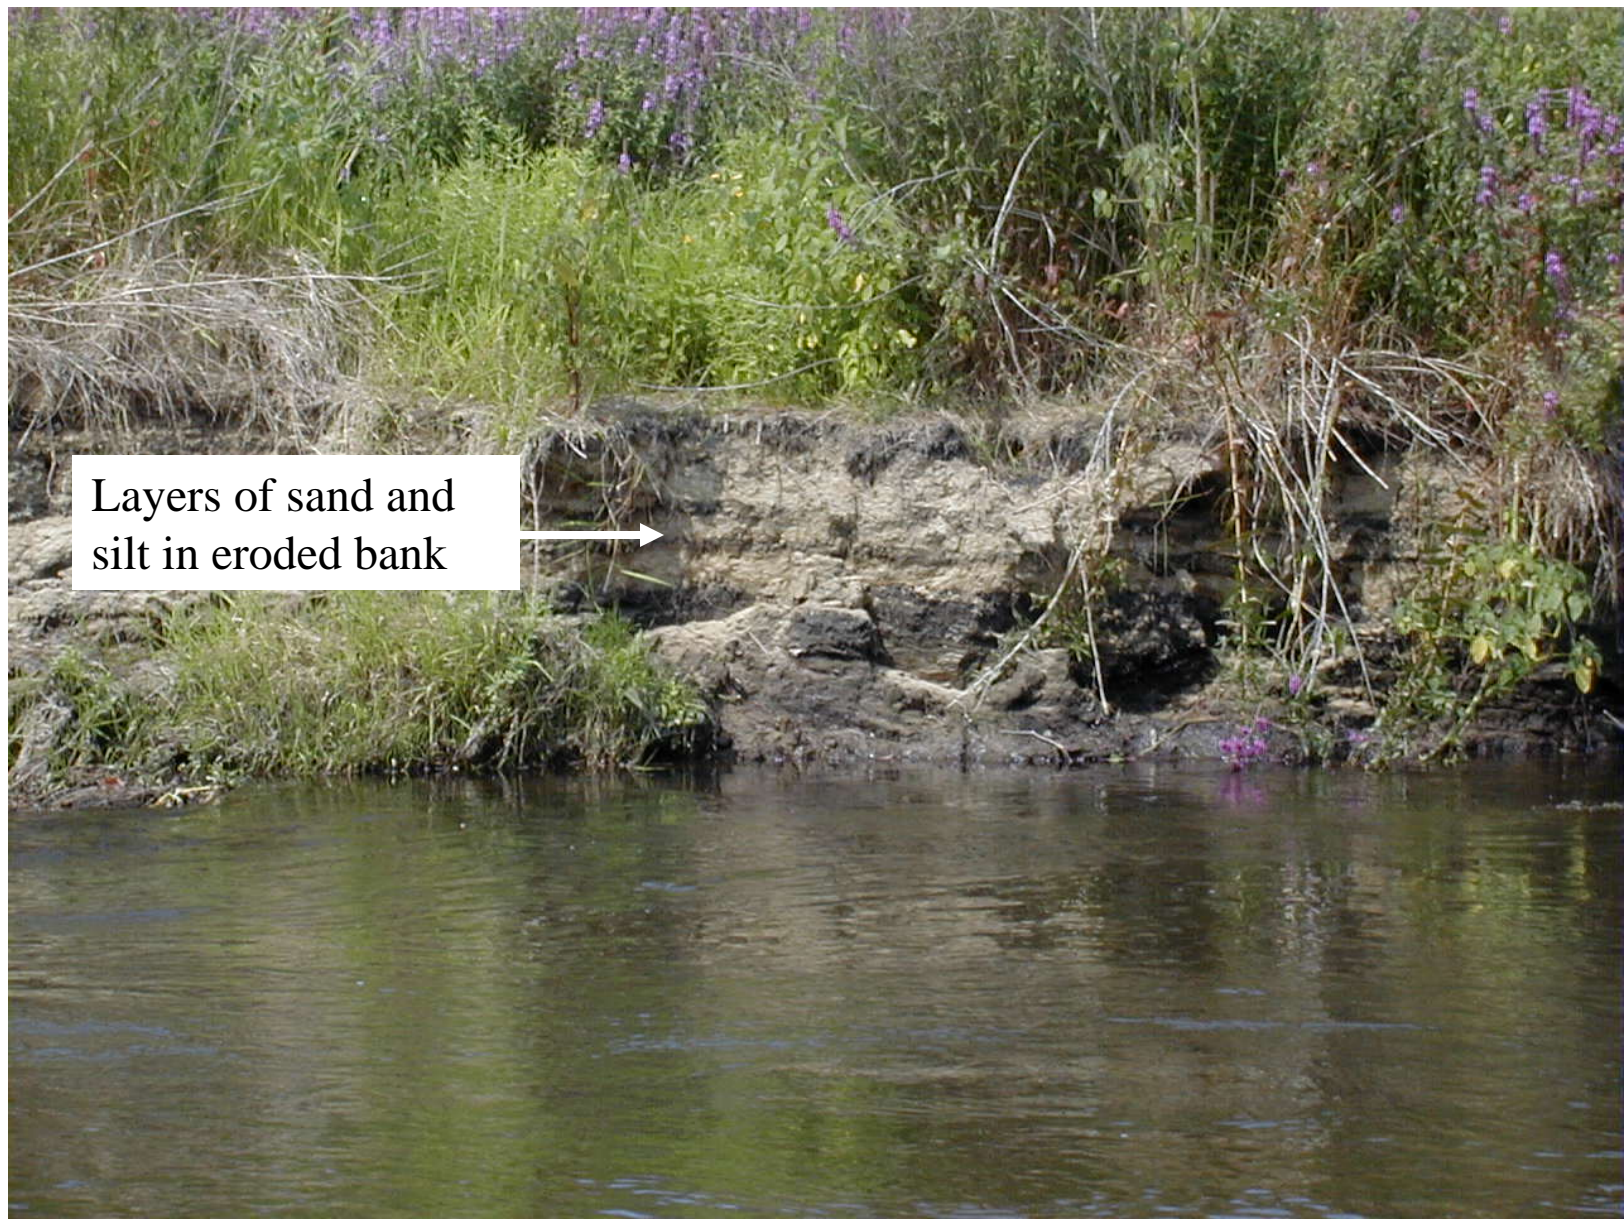
View of cross-section of eroded bank in former impoundment showing multiple layers of silt and sand. This material was soft and easy to probe through before draw down.

The incorrect assumption that mostly silt would move downstream created a situation that required urgent response. The probing samples of the impoundment sediments implied that the material was soft like silt and organic matter and would flush down river with high spring flows. The three week pulse of turbidity below the dam was expected and returned to normal once the draw down was complete. The amount of sand movement was not expected and required management with a sediment trap. After the banks where exposed, it was apparent that sand layers existed in between the silt and organic layers (Appendix 1, Pg 5). These layers of sand were probably deposited in the impoundment during high flow events. Core samples prior to the draw down may have discovered these layers and allowed for a better plan to mitigate the sand.

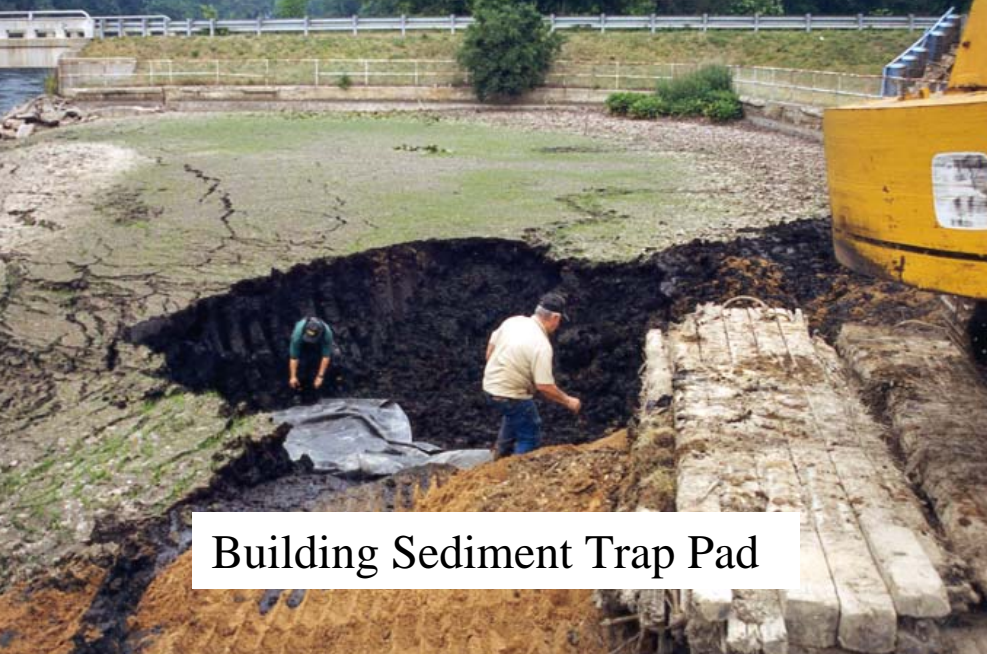
Building Sediment Trap Pad

The deposition of sand observed on June 8, 1999 was of great concern, so the Fisheries Division Heavy Equipment Crew moved in and constructed a sediment trap immediately above the dam on June 10th. An excavator was used to remove organic sediments along the river and replaced them with sand and gravel to create a stable pad for trap cleaning. An extended 60 ft boom excavator was used to reach as far across the river as possible to create a deep hole to collect the sand bedload. The original trap was 95 ft long, 50 ft wide, and 8 ft deep (Appendix 1, Pg 7).

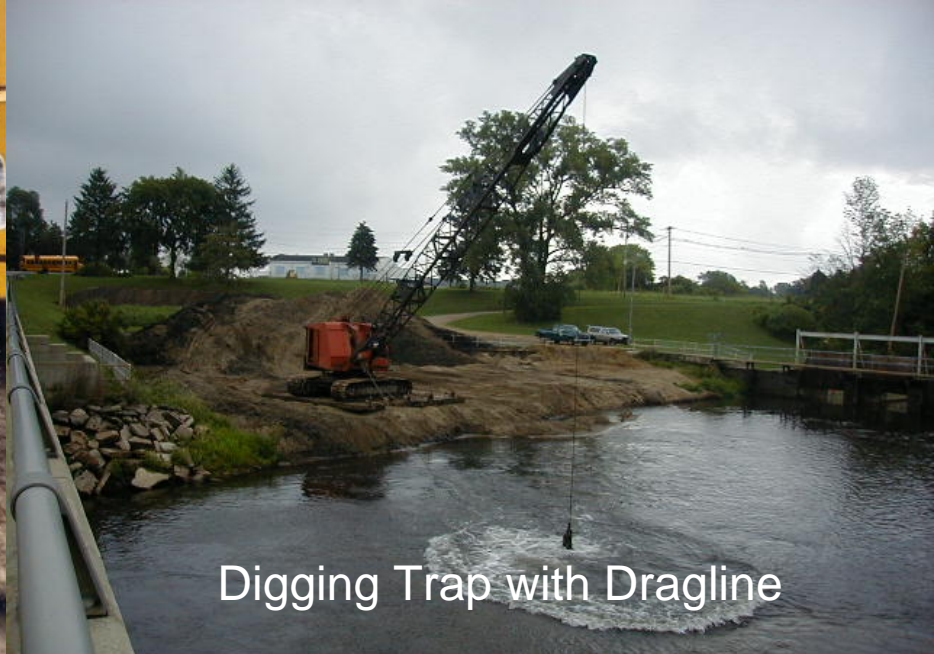
Digging Trap with Dragline

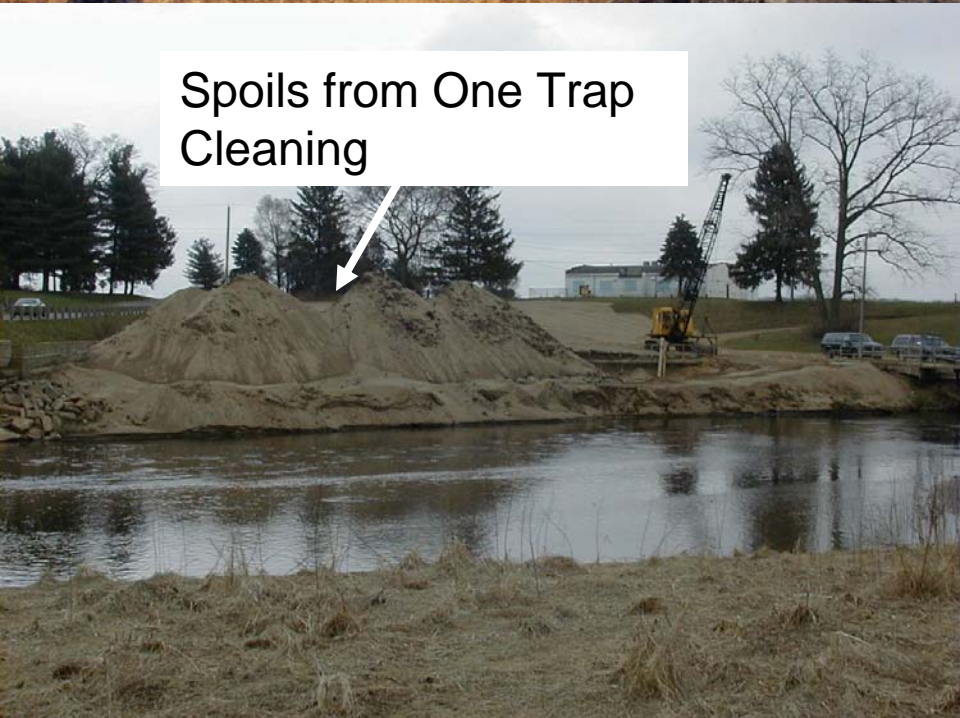
Spoils from One Trap
Cleaning

The sand bedload was so high that the sediment trap filled on a monthly basis. Costs to dredge the trap ranged from \$3,000 to \$4,500 depending on the equipment used and contractor. The Fisheries Division Heavy Equipment Crew cleaned the trap with a rented long reach excavator for \$3,000. A contractor was hired with a drag line that cost \$4,500. The dragline method was preferred because it could dig the trap wider and deeper. The final trap size was 110 ft long, 70 ft wide and 12 ft deep. The trap was maintained until September 2002 when bedload estimates at the dam were equivalent to background estimates. The sediment trap was cleaned 14 times (two times by Fisheries Division and 12 times by contractors) at a total cost of approximately \$50,000, which was shared between Fisheries Division and City of Niles. Approximately, 48,000 cubic yards of sand were removed from the river (Appendix 1, Pg 7).

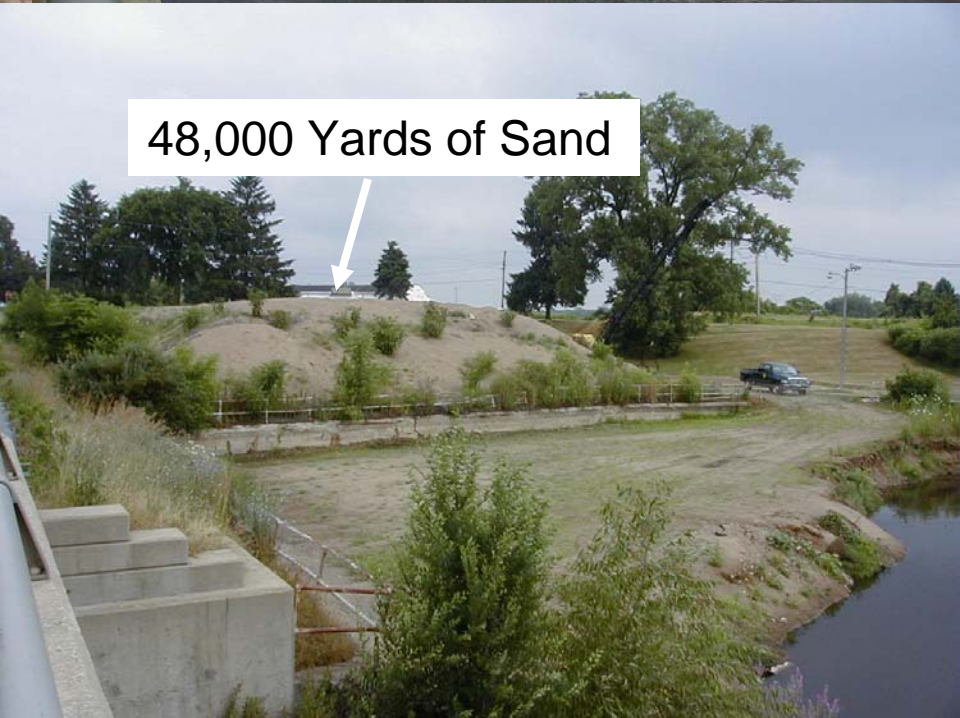
48,000 Yards of Sand

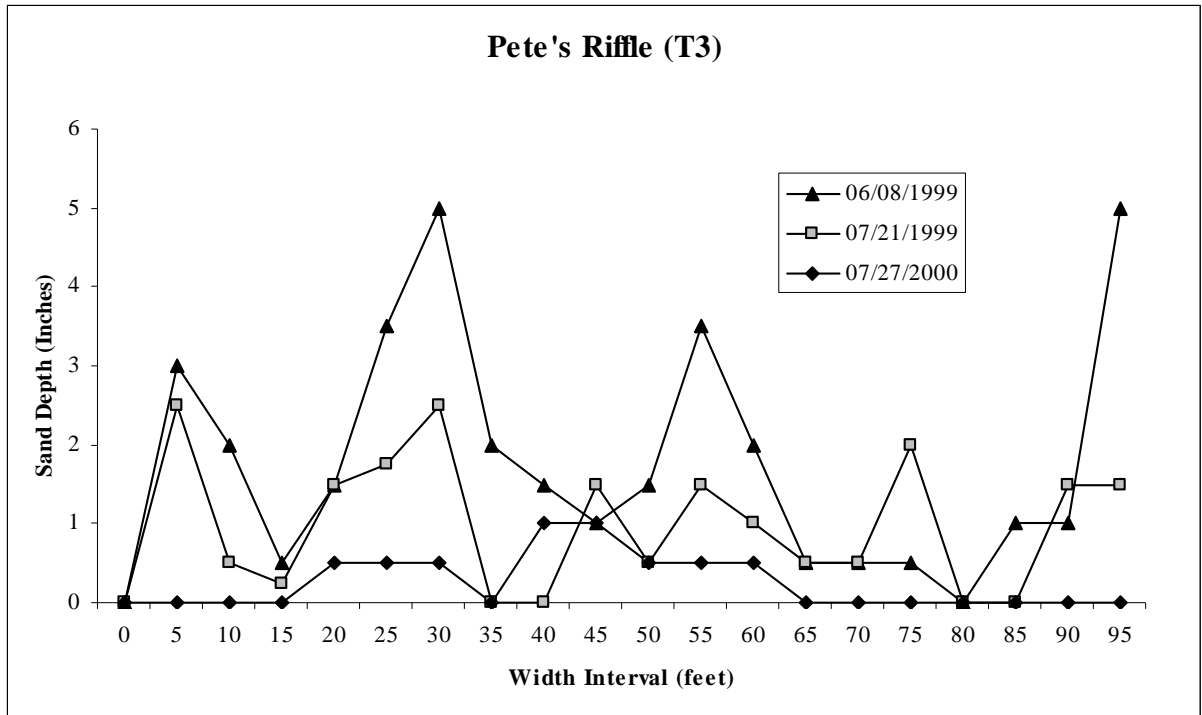
Sand depth cross-section of the Dowagiac River at Pete's riffle (T3).

There was a significant amount of sand ranging from 0 to 18 inches at various intervals within these transects. T1 through T5 had the most sand on June 8th (Figure 6). T6 and T7 had the lowest amount of sand at this time. By July 21, 1999, the riffles showed a decrease in sand indicating that the high velocity areas were starting to clear out. The runs and pools continued to show high amounts of sand. By this time, the sand began to show in the lower transects such as T7 at the Niles Canoe livery. A year after the drawdown, the upper transects (T1-T5) had a decrease in sand with several samples with no sand. However, the lower transects continued to see increases in sand depth a year after draw down (Appendix 2).

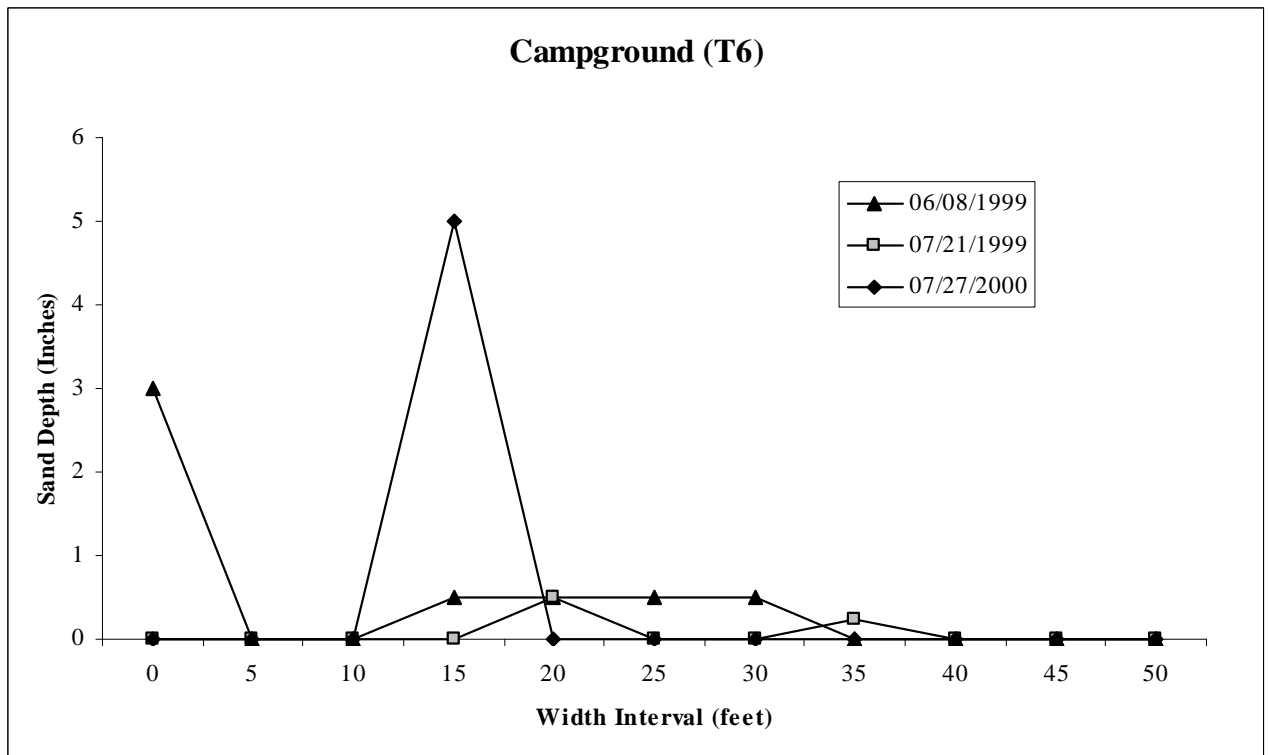
Sand depth cross-section of the Dowagiac River at the campground (T6).
