## **Manton Creek**

Wexford County

Manistee River watershed, last surveyed in September 2014.

**Mark A. Tonello, MDNR ; Christopher A. Pierce, Conservation Resource Alliance**

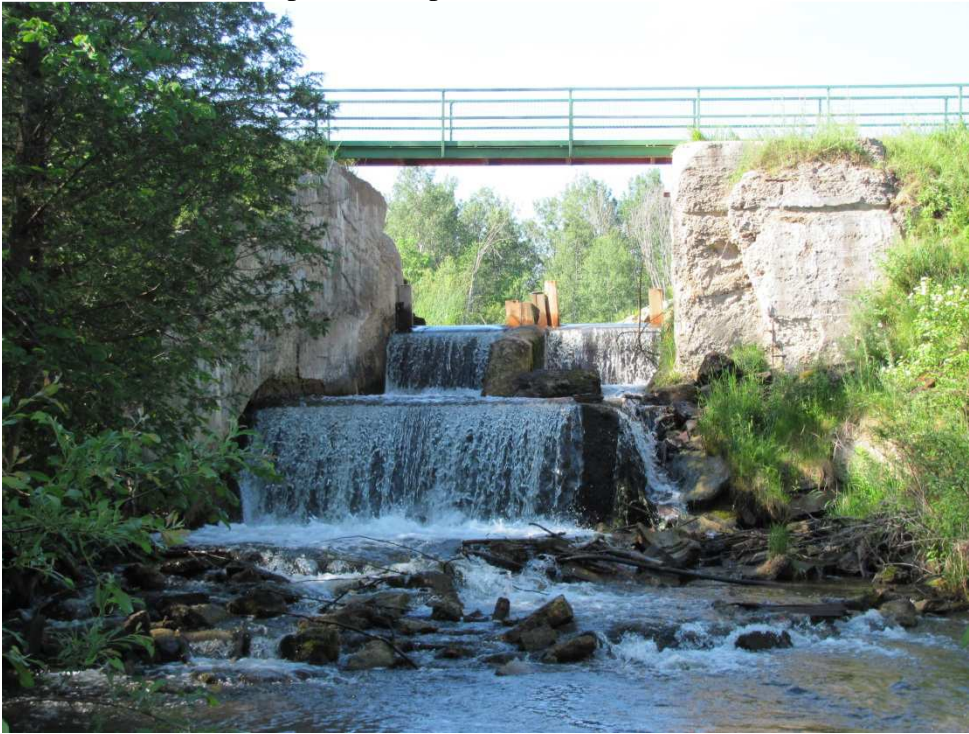
Photo 1. Manton Millpond Dam prior to removal.

File correspondence (Cadillac MDNR office) documents the poor condition of the Manton Millpond Dam as far back as 1973. In 1986, the Manton Millpond Dam was officially documented to be in poor condition (Anonymous 2008). Rozich (1998) first proposed the option of removing it in his Manistee River Assessment. In 2001, the Michigan Department of Environmental Quality (MDEQ), Land and Water Management Division (LWMD) issued an order to the City of Manton to provide a plan and schedule to remove, repair, or replace the failing dam. By the mid-2000s, the dam had continued to deteriorate and fall apart, to the point where very little remained of the original impoundment. Broken concrete and re-rod littered the area around the dam.

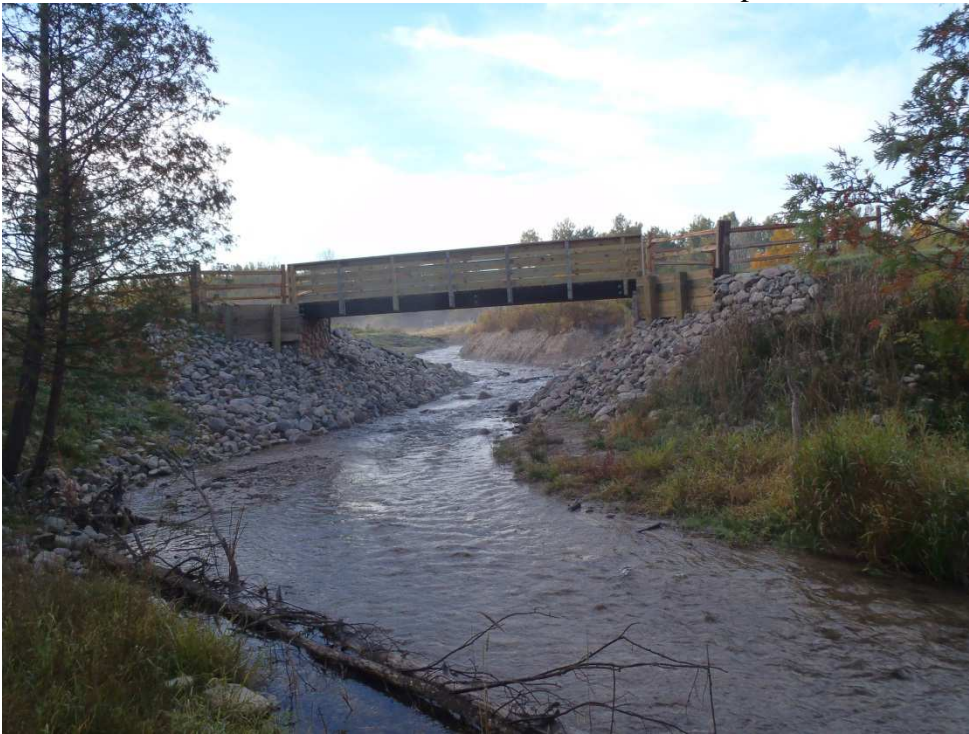
Photo 2. Manton Creek after the removal of Manton Millpond Dam.

Since the removal of the Manton Millpond Dam, Manton Creek has undergone a remarkable transformation. The shallow, warm waters of the historical Millpond have been replaced by a cool, rushing stream with an outstanding trout population. The removal of the Millpond Dam has ensured that Manton Creek is once again a trout stream for its entire length. Prior to the removal of the dam, summer water temperatures downstream of the Millpond Dam were so warm that trout were seasonally excluded. While the Lake Billings Dam also warms Manton Creek, it does not warm it to the extent that trout are excluded below it (Tonello 2004). The 2014 survey showed that brown trout were very abundant in the historical Millpond reach, with multiple year classes represented. Brook trout were less abundant, but present near the confluence of the unnamed tributary stream, which is colder than Manton Creek and thus provides a cooling effect for some distance downstream.

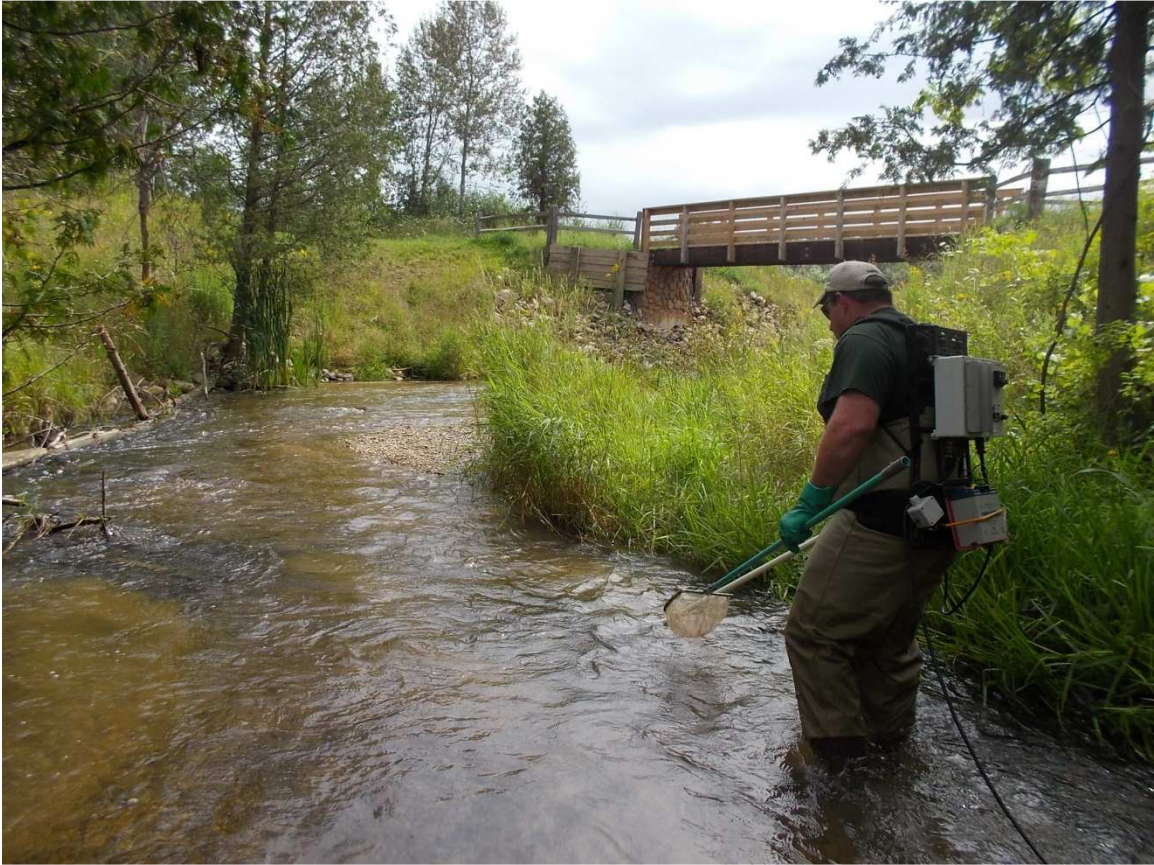
Photo 3. MDNR Fisheries Technician Bob Kerry conducting an electrofishing survey of Manton Creek in the vicinity of the historic Manton Millpond on August 29, 2014.

The most recent fisheries survey of Manton Creek was conducted by MDNR on August 29 and September 4, 2014. Sampling was conducted at three different sites in the watershed (Figure 2), using a Wisconsin battery-powered 12-volt backpack shocker with one probe.

The first site sampled on August 29, 2014 was in the historical reach of the old Manton Millpond (Figure 2). The survey station began approximately 250 feet downstream from the footbridge where the dam stood, and extended another 300 feet upstream from the footbridge (for a total of approximately 550 feet), to the confluence of the unnamed tributary that flows in from the south. At this site, Manton Creek averaged about 14 feet wide and 1 foot deep. Substrates consisted of approximately 30% sand, 30% clay, 30% gravel, 5% cobble, and 5% boulder. Stream channel morphology consisted of 70% run, 15% riffle, and 15% pool. From upstream to downstream, the surveyed reach showed major habitat diversity. The upper portion of the station flows swiftly over gravel with a broad, open channel. The mid-section of the station is narrow and deep with abundant woody cover and overhanging brush. The lower section of the reach is shallow, open, and extremely swift as the creek flows over clay lenses. Below where the historic dam stood, the channel is wide and more open. Substrate initially consists of gravel, cobble, and boulder transitioning to primarily sand near the bottom end of the station as the velocity slows.
