LAND CORNER RECORDATION CERTIFICATE

Filing Requirement of Act 74, Mich. PA 1970

1. Public Land Survey	T	19N	R	12W	H11
	T		R		
2. Property Controlling in Section	S	T	R		
	S	T	R		
3. Miscellaneous Property in Section	S	T	R		
	S	T	R

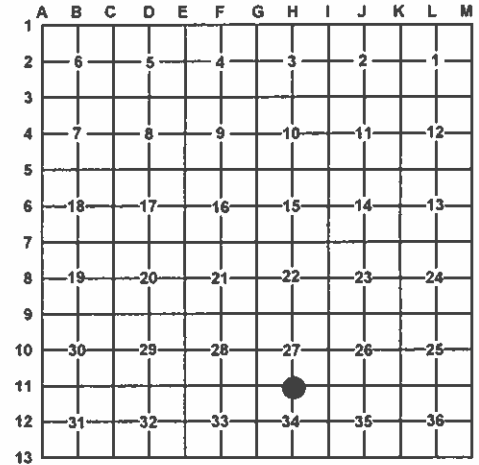
H11 – ¼ corner common to Sections 27 & 34, T19N, R12W – Found ½" x 1.2' long square iron rod in CL. of N-S bit. road. Fence line to west and single strand to the east. Excavated under the ½" iron to the depth of 3' but no other evidence was found. Condition of the witnesses as follows: #1 through 4 are gone; #5 – found large apparent stump mound; #6 & 7 are OK; #8-new post is 33.5' west; #9 is rotten. ½" square iron is accepted as the best available evidence of the position of the original corner.

H11 – Replaced ½" x 1.2' long square iron with stamped 2 ½" brass cap on 5/8" x 34" iron rebar- flush with bit. with concrete around. East 33.00' to set 2" aluminum cap on 5/8" x 34" rebar on line with Blue composite post with location tag. N37°E 49.67' to set mag nail and tag in NW side 16" Oak S67°E 66.31' to set nail and tag in fd. blaze in N side 20" Oak (#6) S45°W 52.76' to set nail and tag at fd. cut nail in SE side power pole (#7) N52°W 75.24' to set nail and tag in SW side 10" Red Pine
