LAND CORNER RECORDATION CERTIFICATE
Filing Requirement of Act 74, Mich. P.A. 1970

Ontonagon
 (County)

| 1. Public Land Survey | T <u>53N</u> R <u>38W</u> | <u>17</u> |

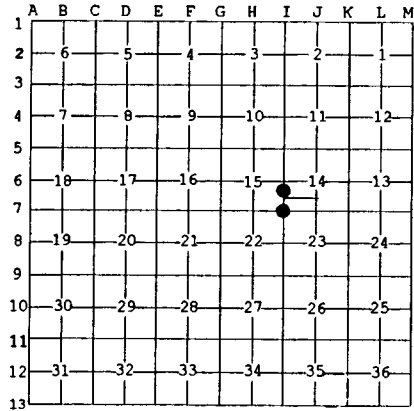
A. Description of original monument and accessories and/or subsequent restoration:

(17) Section corner common to 14-15-22-23. Reestablished in 1965 by Billy D. Buckler, RLS. 1" pipe with 4" aluminum cap. No witness trees made.

(WC N. of 17) Witness corner. A point on the section line between sections 14-15. Not established in the original survey. Established in 1965 by Billy D. Buckler, RLS. 1" pipe with 4" aluminum cap. 24" W.Pine S50W 35 links, 16" W.Pine S56E 56.5 links. This corner previously recorded by Buckler as "Meander corner between Sections 14-15 on Lake Superior".

(17) Recovered the 1965 monument in good condition, adjacent to Buckler's squared cedar post. Bearings to 1965 corners N 02 deg 55'50"E 1358.75' and S 03 deg 03'08"W 2632.23' as well as my measure to 1/4 cor. east (2731.2 M, 2733.1 BDB) confirm that the position of the monument is the 1965 position (bearings above are NAD83 - 1994 adjustment grid bearings).

(WC N. of 17) The 1965 monument was not recovered. Found a squared and scribed post at record bearing and distance from the 1965 witness trees. The W.Pine witness SE is now a windthrow, the W.Pine SW is in good condition. Remonumented the corner at the position of the post with a 1" IDx 32" iron pipe capped with a 4" dia. cast aluminum MDNR tablet, stamped "Meander Corner Sec 15 Sec 14 PS33986 5-1-00". This monument is on the section line between 14&15 and 1358.75' North of corner 17.
