LAND CORNER RECORDATION CERTIFICATE
Filing Requirement of Act 74, Mich. P.A. 1970

For corners in
Bickinson

1. Public Land Survey

T 43N R 29W

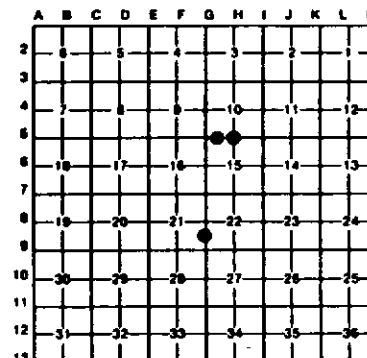
A. Description of original monument and accessories and/or subsequent restoration:

(NS) Quarter corner common to Sections 10-15. Original corner established in 1848 by Harvey Mellen as follows: Set cedar post. Yellow Birch 30 S48E 23, Hemlock 8 N40W 10. Found no subsequent record.

(10-Sec.22) South 1/10 corner between Sections 21-22. Corner not established in the original survey. Found no subsequent record.

(1-Sec. 15) West 1/10 corner between Sections 10-15. Corner not established in the original survey. Found no subsequent record.

B. Description of corner evidence found and/or method applied in restoring or reestablishing corner:

(NS) Original post and accessories not recovered. Found no monumentation at the corner position and no acceptable evidence of the position of the original corner on the ground. Reestablished the corner on a straight line between Section corners 2653.00' East and West, being the proportionate position. At the position for the corner, I placed a 1" I.D. x 32" iron pipe capped with a 4" dia. cast aluminum MONR tablet, appropriately stamped.

(10-Sec.22) Found no evidence of prior monumentation at the corner position. Established the corner on a straight line between Quarter corner 1323.57' North and Section Corner recorded by A.O. Enger in 1900 1323.57' South. At the position for the corner, I placed a 1" I.D. x 32" iron pipe capped with a 4" dia. cast aluminum MONR tablet, appropriately stamped.

(1-Sec.15) Found no evidence of prior monumentation at the corner position. Established the corner on a straight line between Section corner 1326.50' West and Quarter corner 1326.50' East. At the position for the corner, I placed a 1" I.D. x 32" iron pipe capped with a 4" dia. cast aluminum MONR tablet, appropriately stamped.
