## LAND CORNER RECORDATION CERTIFICATE

Filing Requirement of Act 74, Mich. P.A. 1970

E-5 CORNER COMMON TO SECTIONS 8, 9, 16 & 17 T16N, R15W COLFAX TOWNSHIP  
GLO John Hodgson 1838 SET POST 12" Maple N40°W 36 lks 18" Beech S61°E 34 lks  
Book C, Pg. 106, HA Grant, 1905; Sec. 17-16-15 Breakdown "Iron Rod set by J. Bean 1883."  
1) 28" Pine Stump N19.25°W 86 lks 2) 28" Pine Stump S76.5°E 31 lks  
Book C, Pg. 108, HA Grant, 1905; Sec. 8-16-15 Breakdown "See No. 2, Page 106."  
Book C, Pg. 110, HA Grant, 1905; Sec. 16-16-15 Breakdown "See No. 2, Page 106."  
Book C, Pg. 150, E.M. Hyde, 1910; Sec. 9-16-15 Breakdown "Found iron rod for corner."

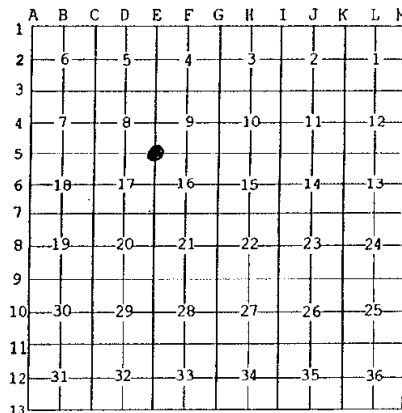
### A. Description of original monument and accessories and/or subsequent restoration:

- OCRC Witness Book 1955 3/4" Iron Rod 3) 30" Pine Stump N43°W 78.7' 4) 30" Pine Stump S50°E 81.75'  
LCRC #100473, Larry Gerschbacher #18990, 1/29/75 Found 3/4" Iron re-bar  
5) SE corner concrete block house N41°W 127.73' 6) Power Pole N40°E 54.08' 7) Power Pole S42°30'W 48.93'

- 6) PK Nail SE Face P pole 39°az 54.09' 8) SW Cor Hse Foundation 49°az 145.68'  
7) 16d spk in E Face P pole 222°az 48.70' 9) 60d spk in E Face 10" Pine 209°az 93.20'

I found two iron rods which have been known to me since 1989 to exist at this location. I found a 3/4" Iron rod 8" below the surface in the centerline road intersection E-W-N-SE. This 3/4" Iron is 2.26' South and 1.62' East of a 1/2" galvanized threaded rod with two nuts (similar to those used on power line poles) which was 2" below the surface. Upon excavation and removal of the 1/2" threaded rod, I did not detect any other iron object. Upon excavation and removal of the 3/4" Iron, I found it to be a well-rusted axle shaft 20" long. Below the 3/4" Iron, I found much broken old glass and crockery. No other iron object was detected in the vicinity. I did not accept the 1/2" threaded rod as it has no historical usage known to me and nothing else to commend it except its mere existence. I accept the 3/4" Iron which in my opinion is also the OCRC 1955 corner and the LCRC 100473 corner. I removed and discarded the 1/2" threaded rod. The Grant, 1905, witnesses and OCRC, 1955, witnesses are all missing.
