## LAND CORNER RECORDATION CERTIFICATE Filing Requirement of Act 74, Mich. P.A. 1970

## F-13 S. 1/4 CORNER OF SECTION 33, T4N-R6E, TYRONE TOWNSHIP, LIVINGSTON COUNTY, MICHIGAN.

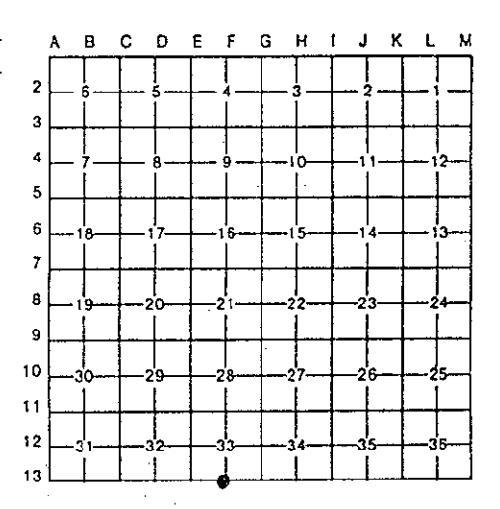
Found 1/2" iron. Fit witnesses by Albright

F-13	<u>S 1/4 Cor. SE</u>	<u>C. 33 T4N-F</u>	16E			
-	Set 1 1/4" x in cente	36" Breakawa erline Parsha	y iron pipe wi llville Road	ith brass c	ap (Liv. Co. Mon. C	or.)
e Constantino de Cons	N54°E 51.22'	spike W/S 24	" Hickory			
	S56°E 45.32'			-		
	S45°W 28.80'				L 345 1990, APPROVED BY	LNINGSTON COUNTY
	N52°W 60.28'	Spike S/S 24	" Apple		1 200 1000 107/95	AN BED JED
			TE OF MICH	Salty PE	R GROUP ON <u>677/95</u>	
, • ;		$\neg 0$	ANDERSON	! <b>\</b> * }		
Signed by	C. Cla	and and the	ENGINEER		<u>July 5, 1995</u>	
•	chigan License No.	11495	NO. NO. T1295 NO. T1295 NO. NO.		FORM APPROYED BY MICHIGAN STATE BO	ARD OF LAND SURVEYORS, JAN. 28, 1971 Revised May 14, 1975 , Revised Jan., 1983
