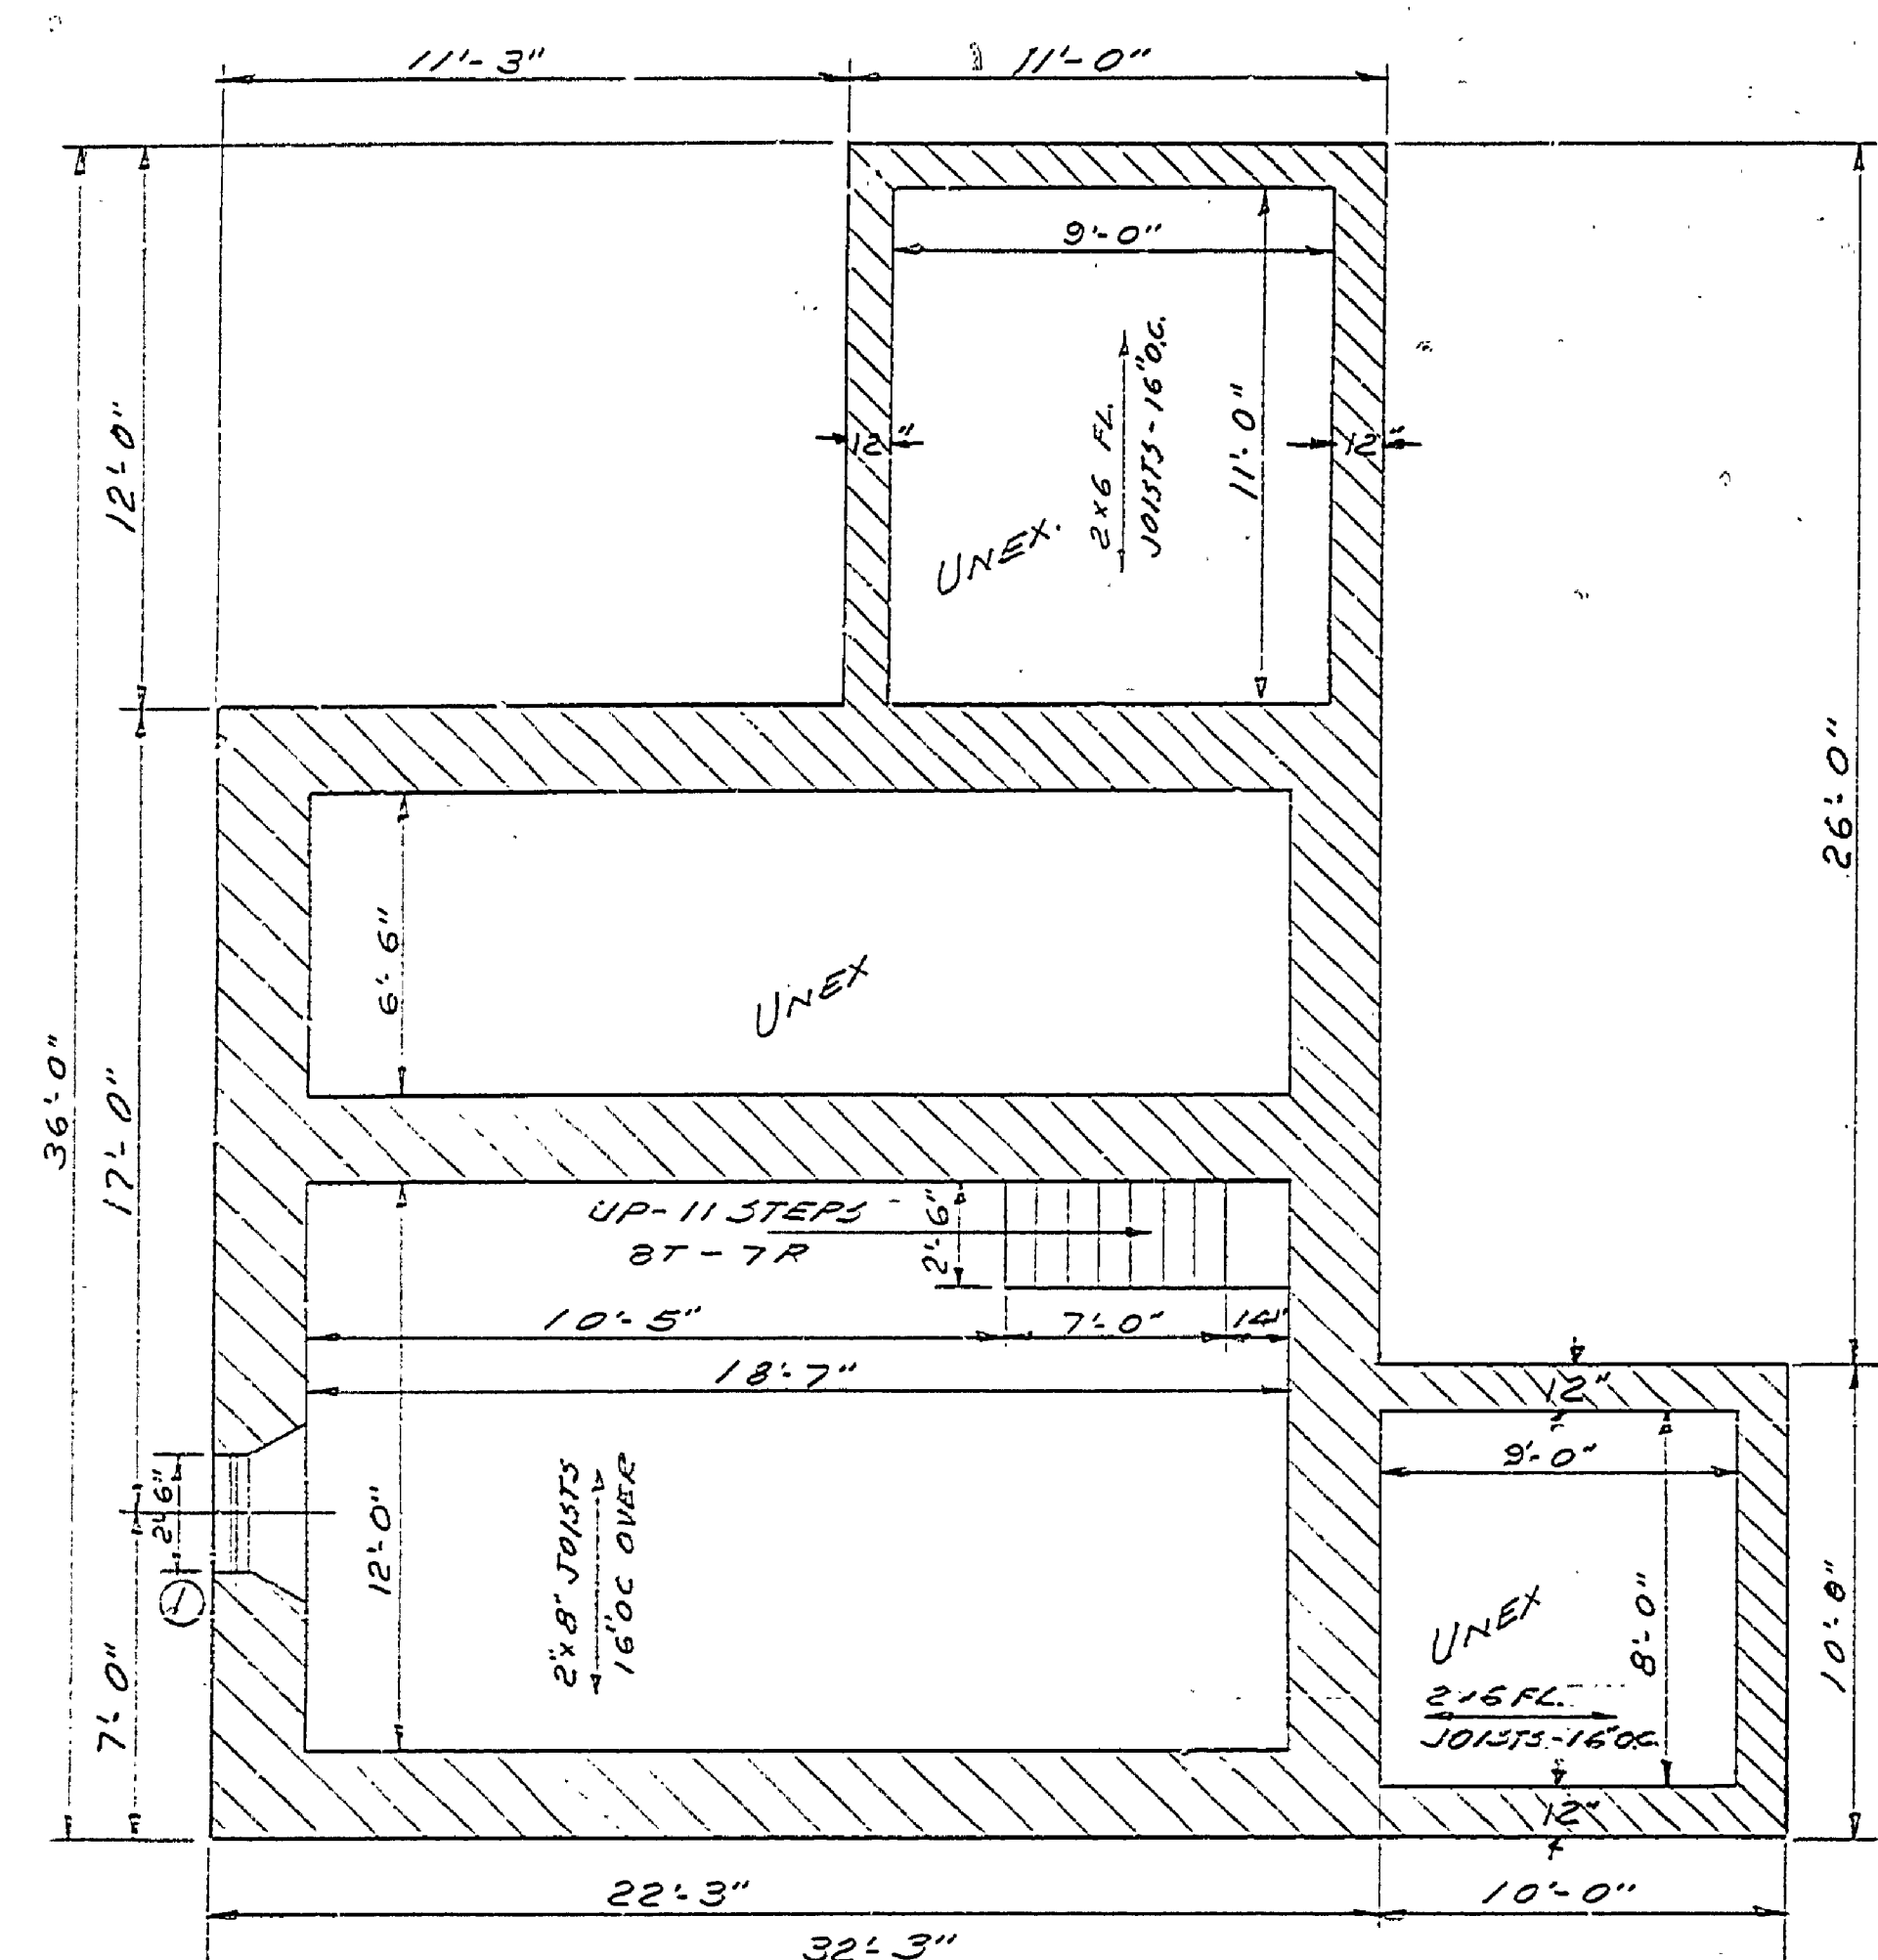
MATERIAL - NATURAL LIMESTONE  
ALL WALLS ARE 22" THICK UNLESS NOTED  
BASEMENT & FOUNDATION

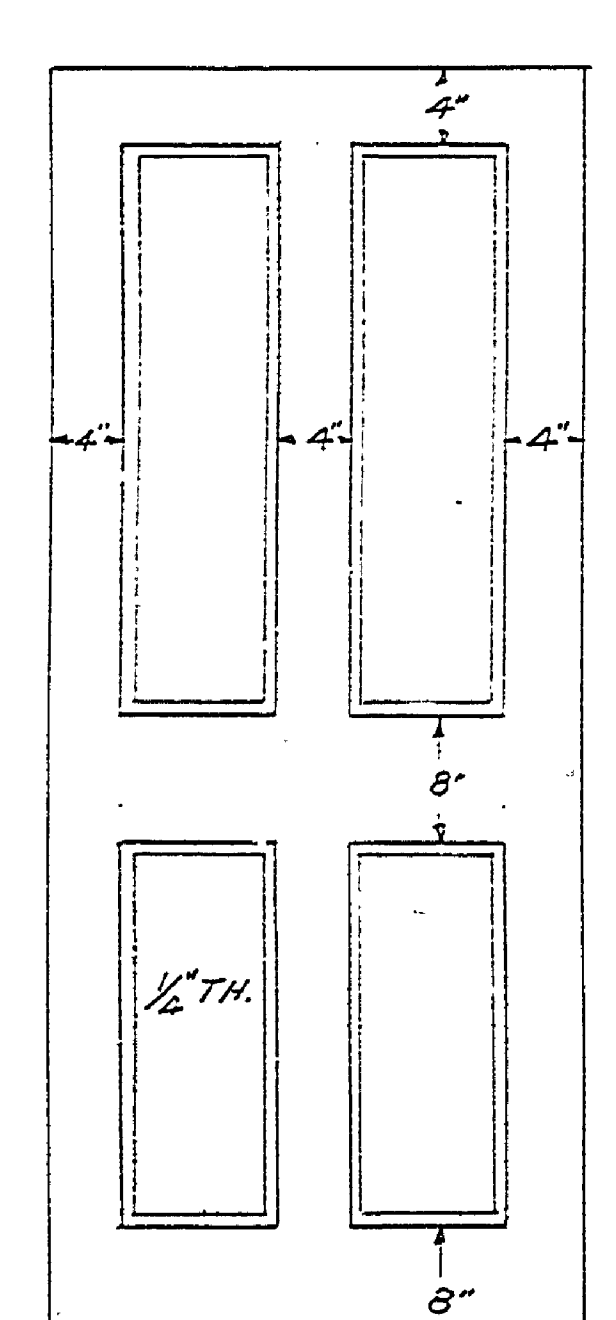
TYPICAL PANEL DOOR DETAIL  
1/8" THICKNESS  
SCALE

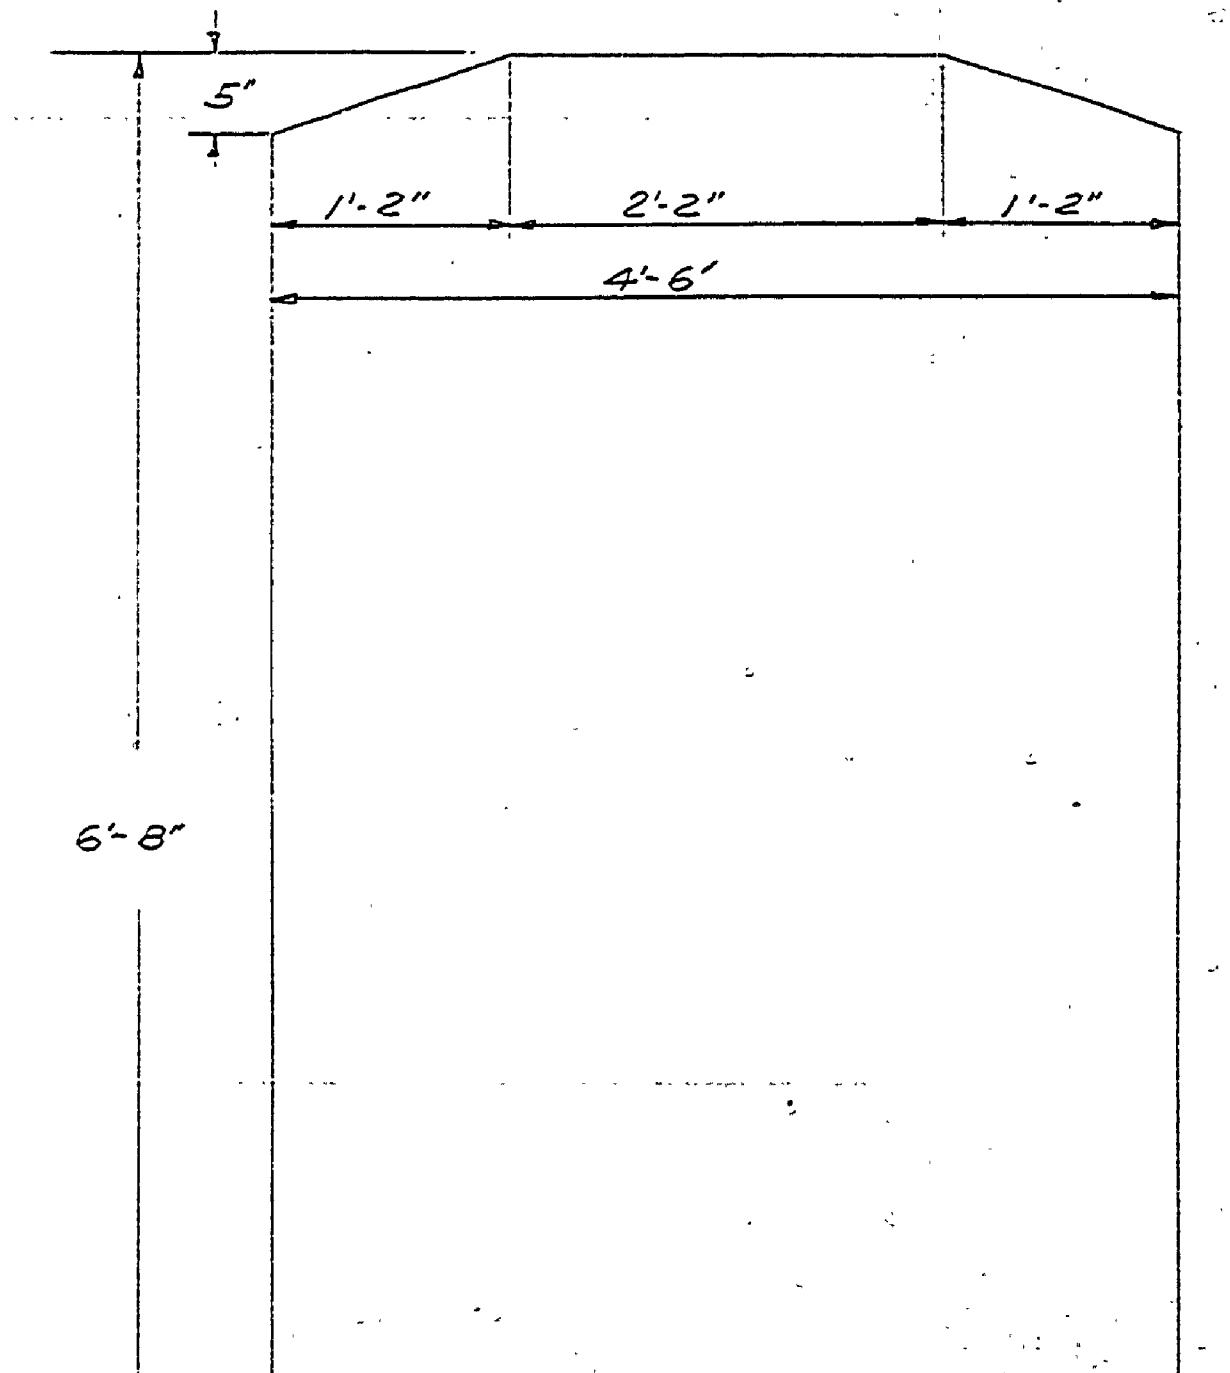
ARCH. DETAIL BETWEEN  
LIVING RM. & DINING RM.
