SPECIAL NOTE
HOUSES #25 & 27 ARE IDENTICAL IN CONSTRUCTION

BLO'S No. 25-27

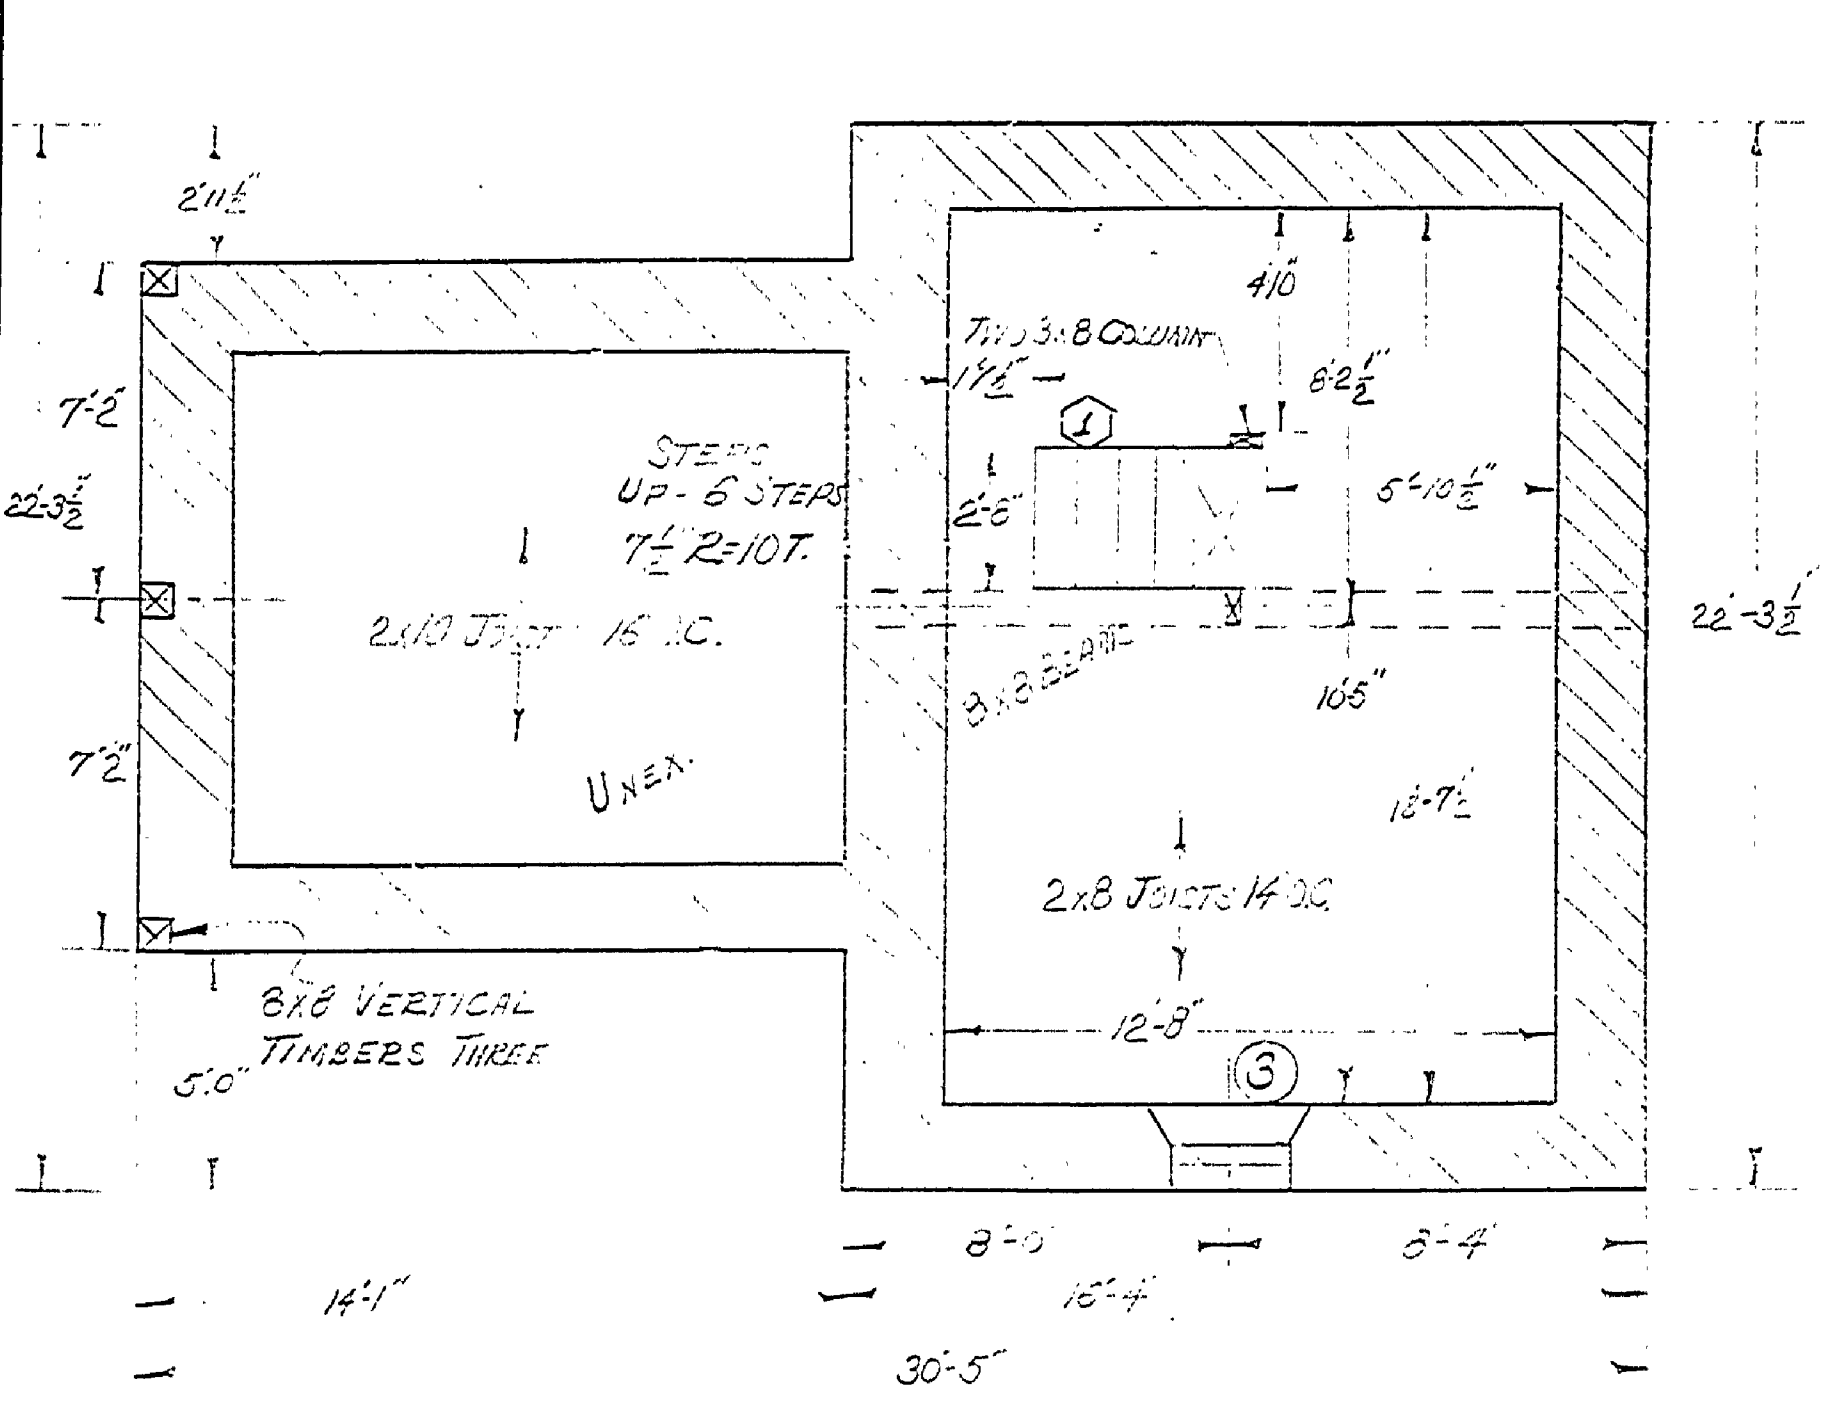
WALLS ARE 22" THICK
MADE OF NATURAL LIMESTONE
BASEMENT F. FOUNDATION

- NOTES
- ① BASEMENT STAIRS IN VERY POOR CONDITION. DIRECTLY BELOW STAIRS IS A LIMESTONE BENCH APPROX. 3'-0" WIDE. FULL WIDTH OF BASEMENT THAT WAS NOT REMOVED DURING CONSTRUCTION. ONE MUST COME DOWN THE STAIRS TURN LEFT AND COME DOWN THE BENCH TO REACH BASEMENT PROPER.
 - ② STAIRS & PORCH MISSING.
 - ③ PORCH MISSING.
 - ④ CHIMNEY HAS BEEN REMOVED JUST UNDER R.F.P.
 - ALL DOORS MARKED WITH 'A' DO NOT FIT PROPERLY.
 - AREA #304 IS UNFINISHED, STAIRS & SPACE ONLY.
