NOTE: THESE DRAWINGS ARE TO BE USED FOR RESTORATION PURPOSES ONLY. FOR INFORMATION & DIMENSIONS ON EXISTING STRUCTURE SEE MEASURED DRAWINGS. THE NEW DETAILS & ADDITIONS SHOWN ON THESE DRAWINGS WERE TAKEN FROM PHOTOS MADE DURING 1907 SURVEY & OBSERVATION OF EXISTING STRUCTURE. DETAILS ARE AS AUTHENTIC AS POSSIBLE.
BLDG. #26627-(IDENTICAL)

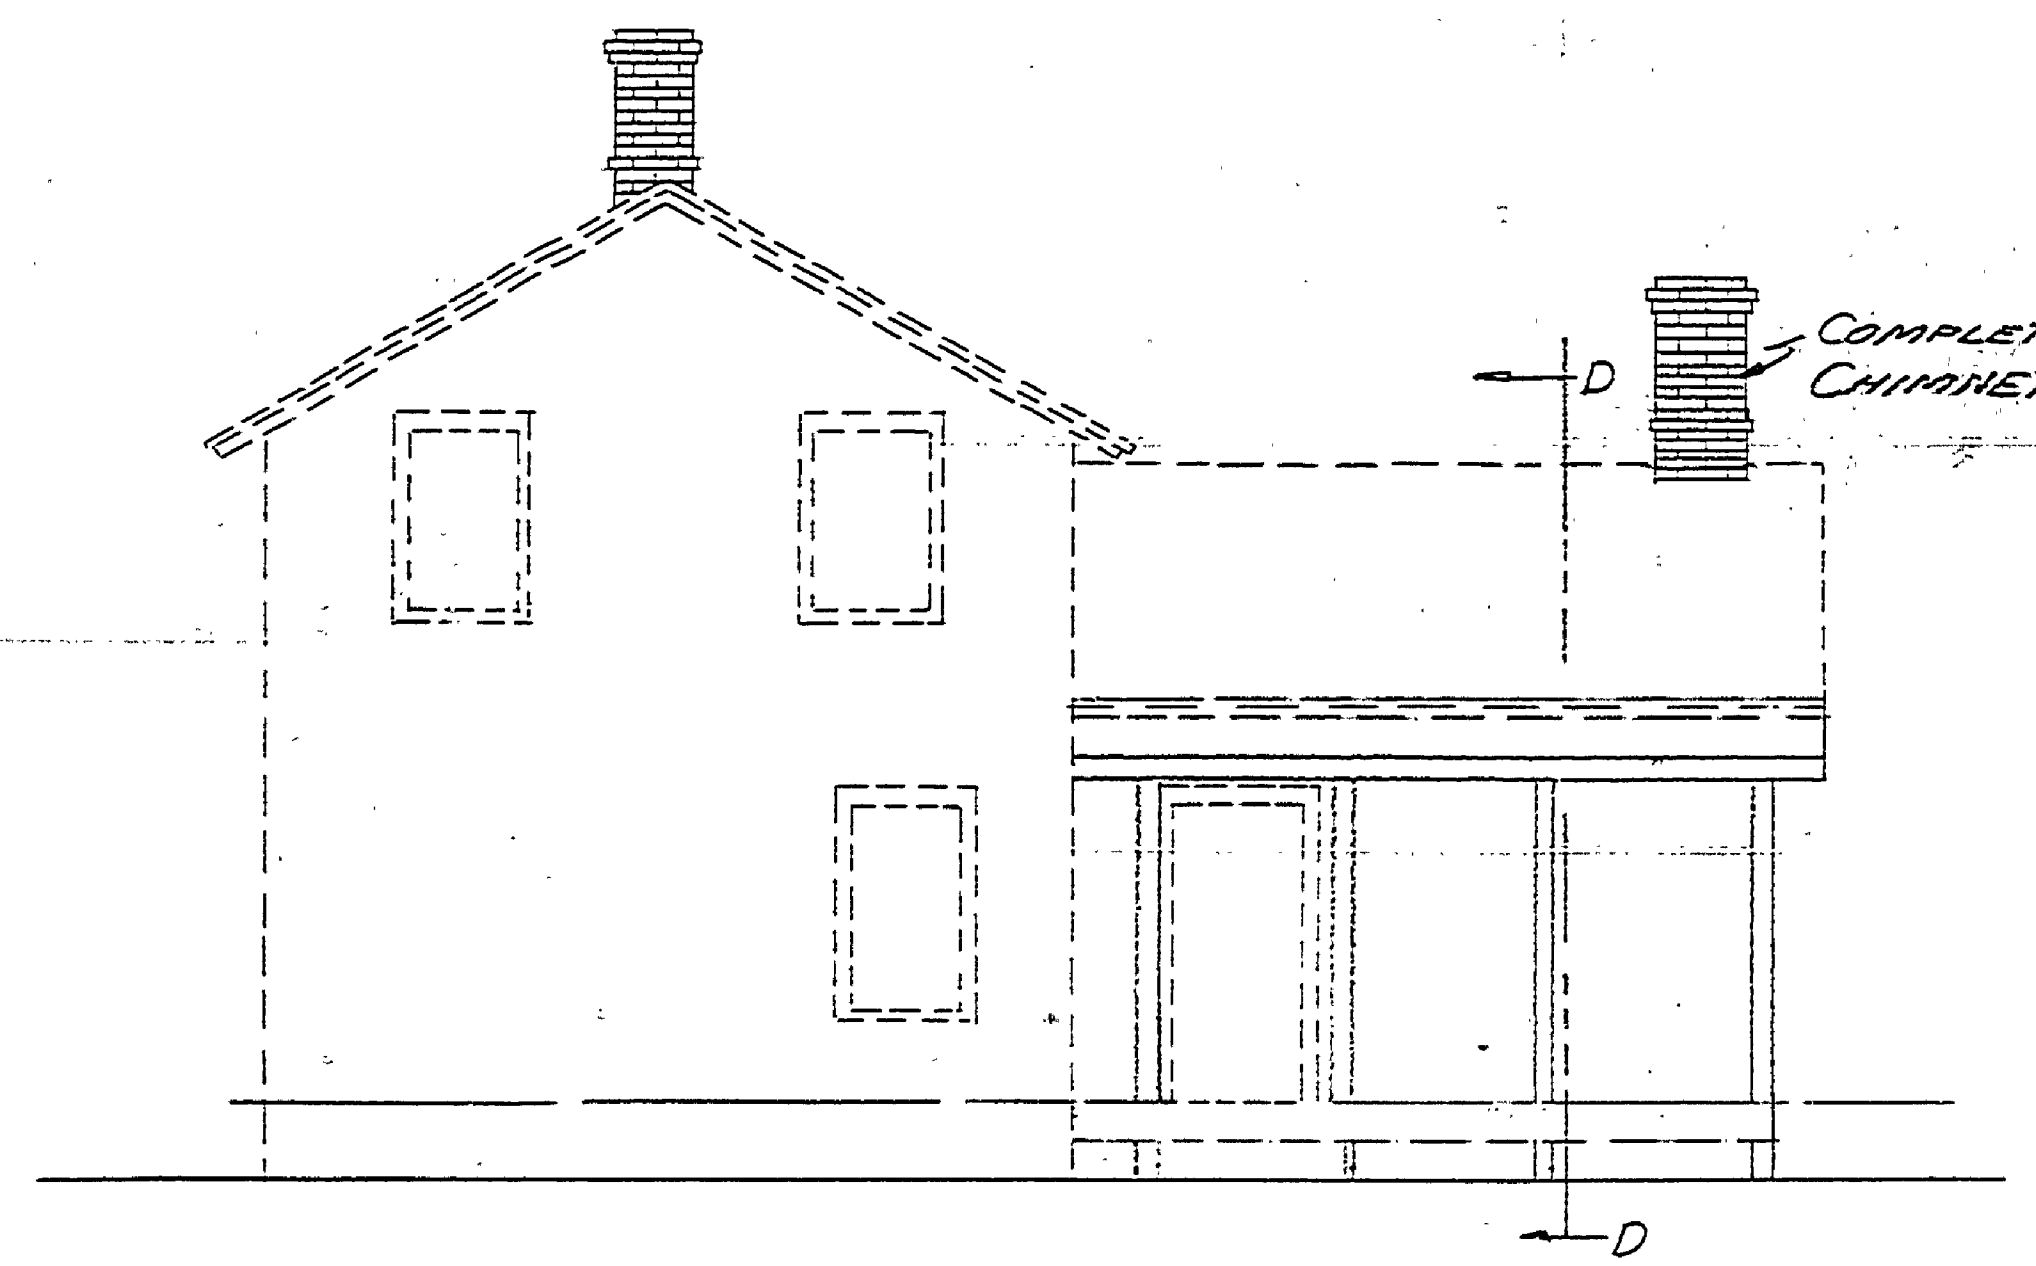
EAST ELEVATION

NOTE: ALL DOORS INDICATED WITH A DOT • MUST BE REPLACED

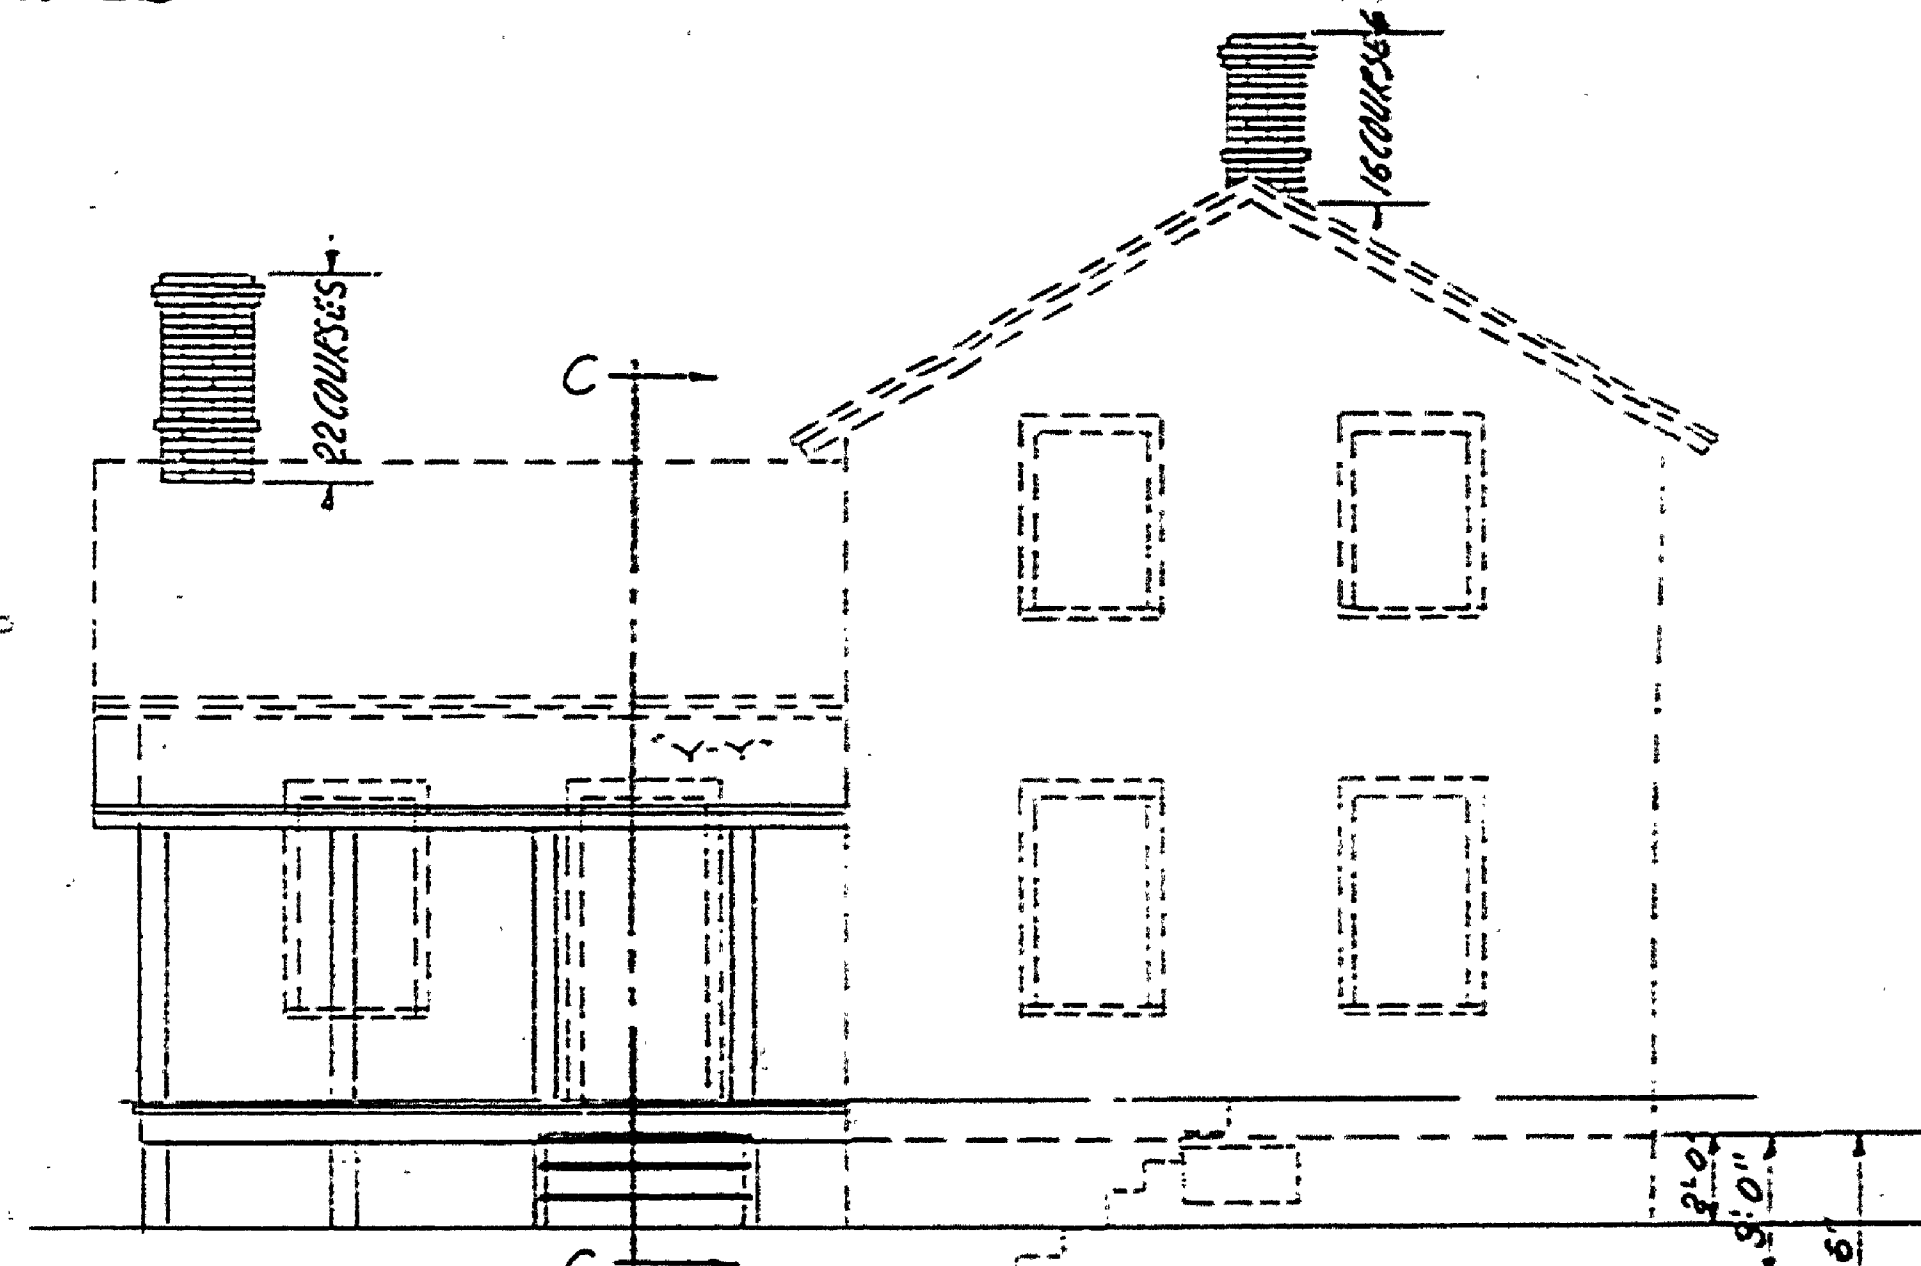
WEST ELEVATION

NOTE: HIDDEN LINES FOR EXISTING PARTS
SOLID LINES FOR PARTS TO REPLACE
SCALE 1/4" = 1'-0"
