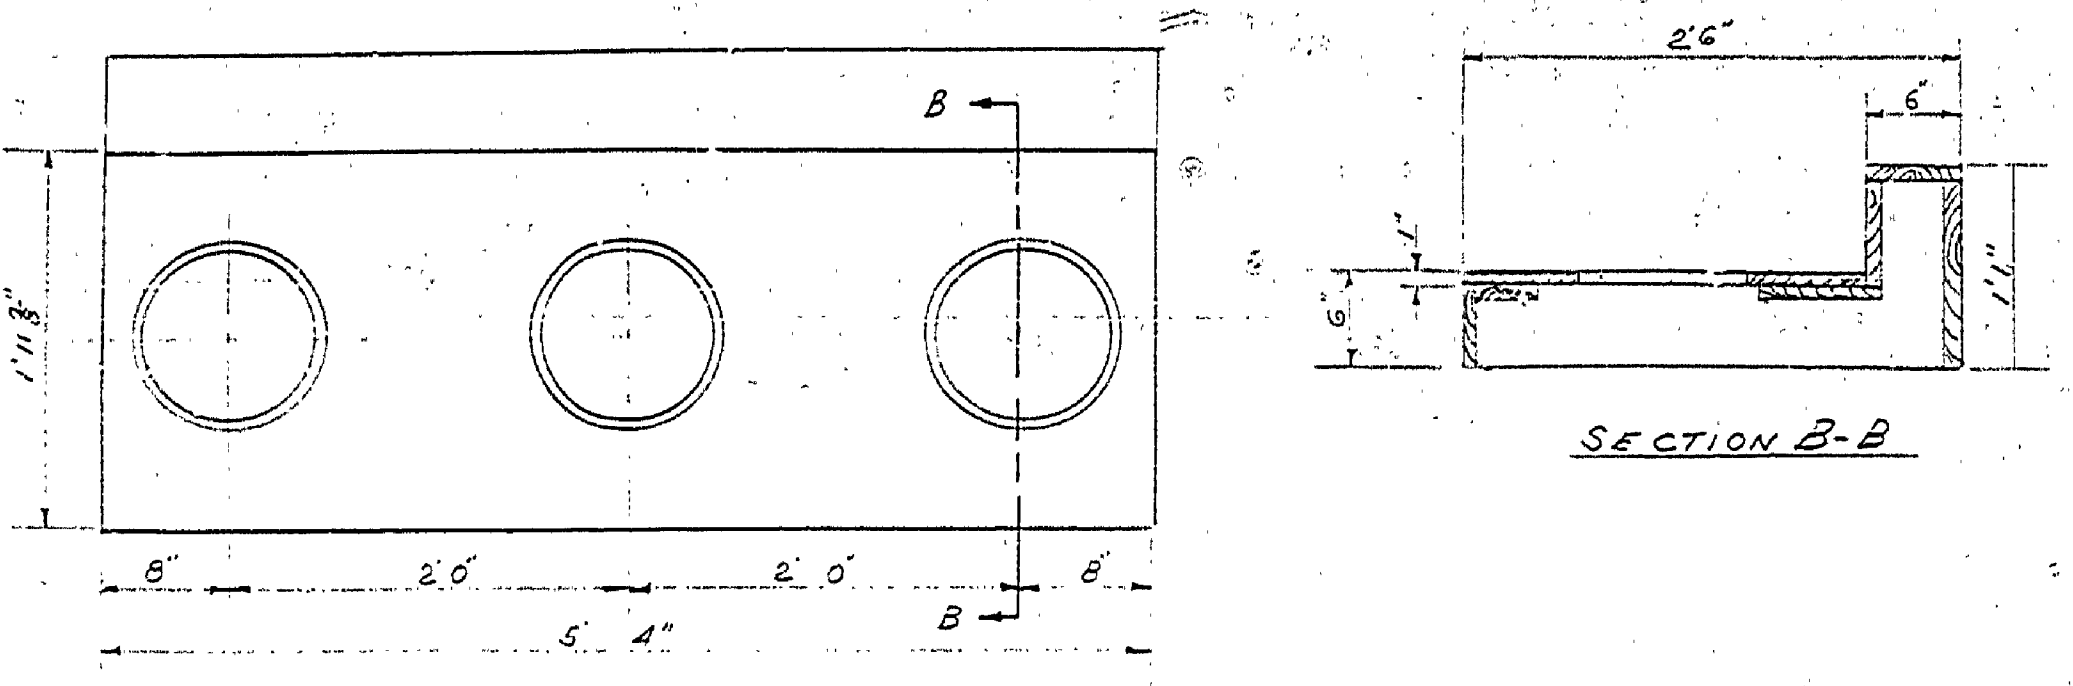
ORIGINAL LOCATION OF THIS UNIT NOT KNOWN, PRESENTLY FASTENED ON TOP OF BATHTUB.

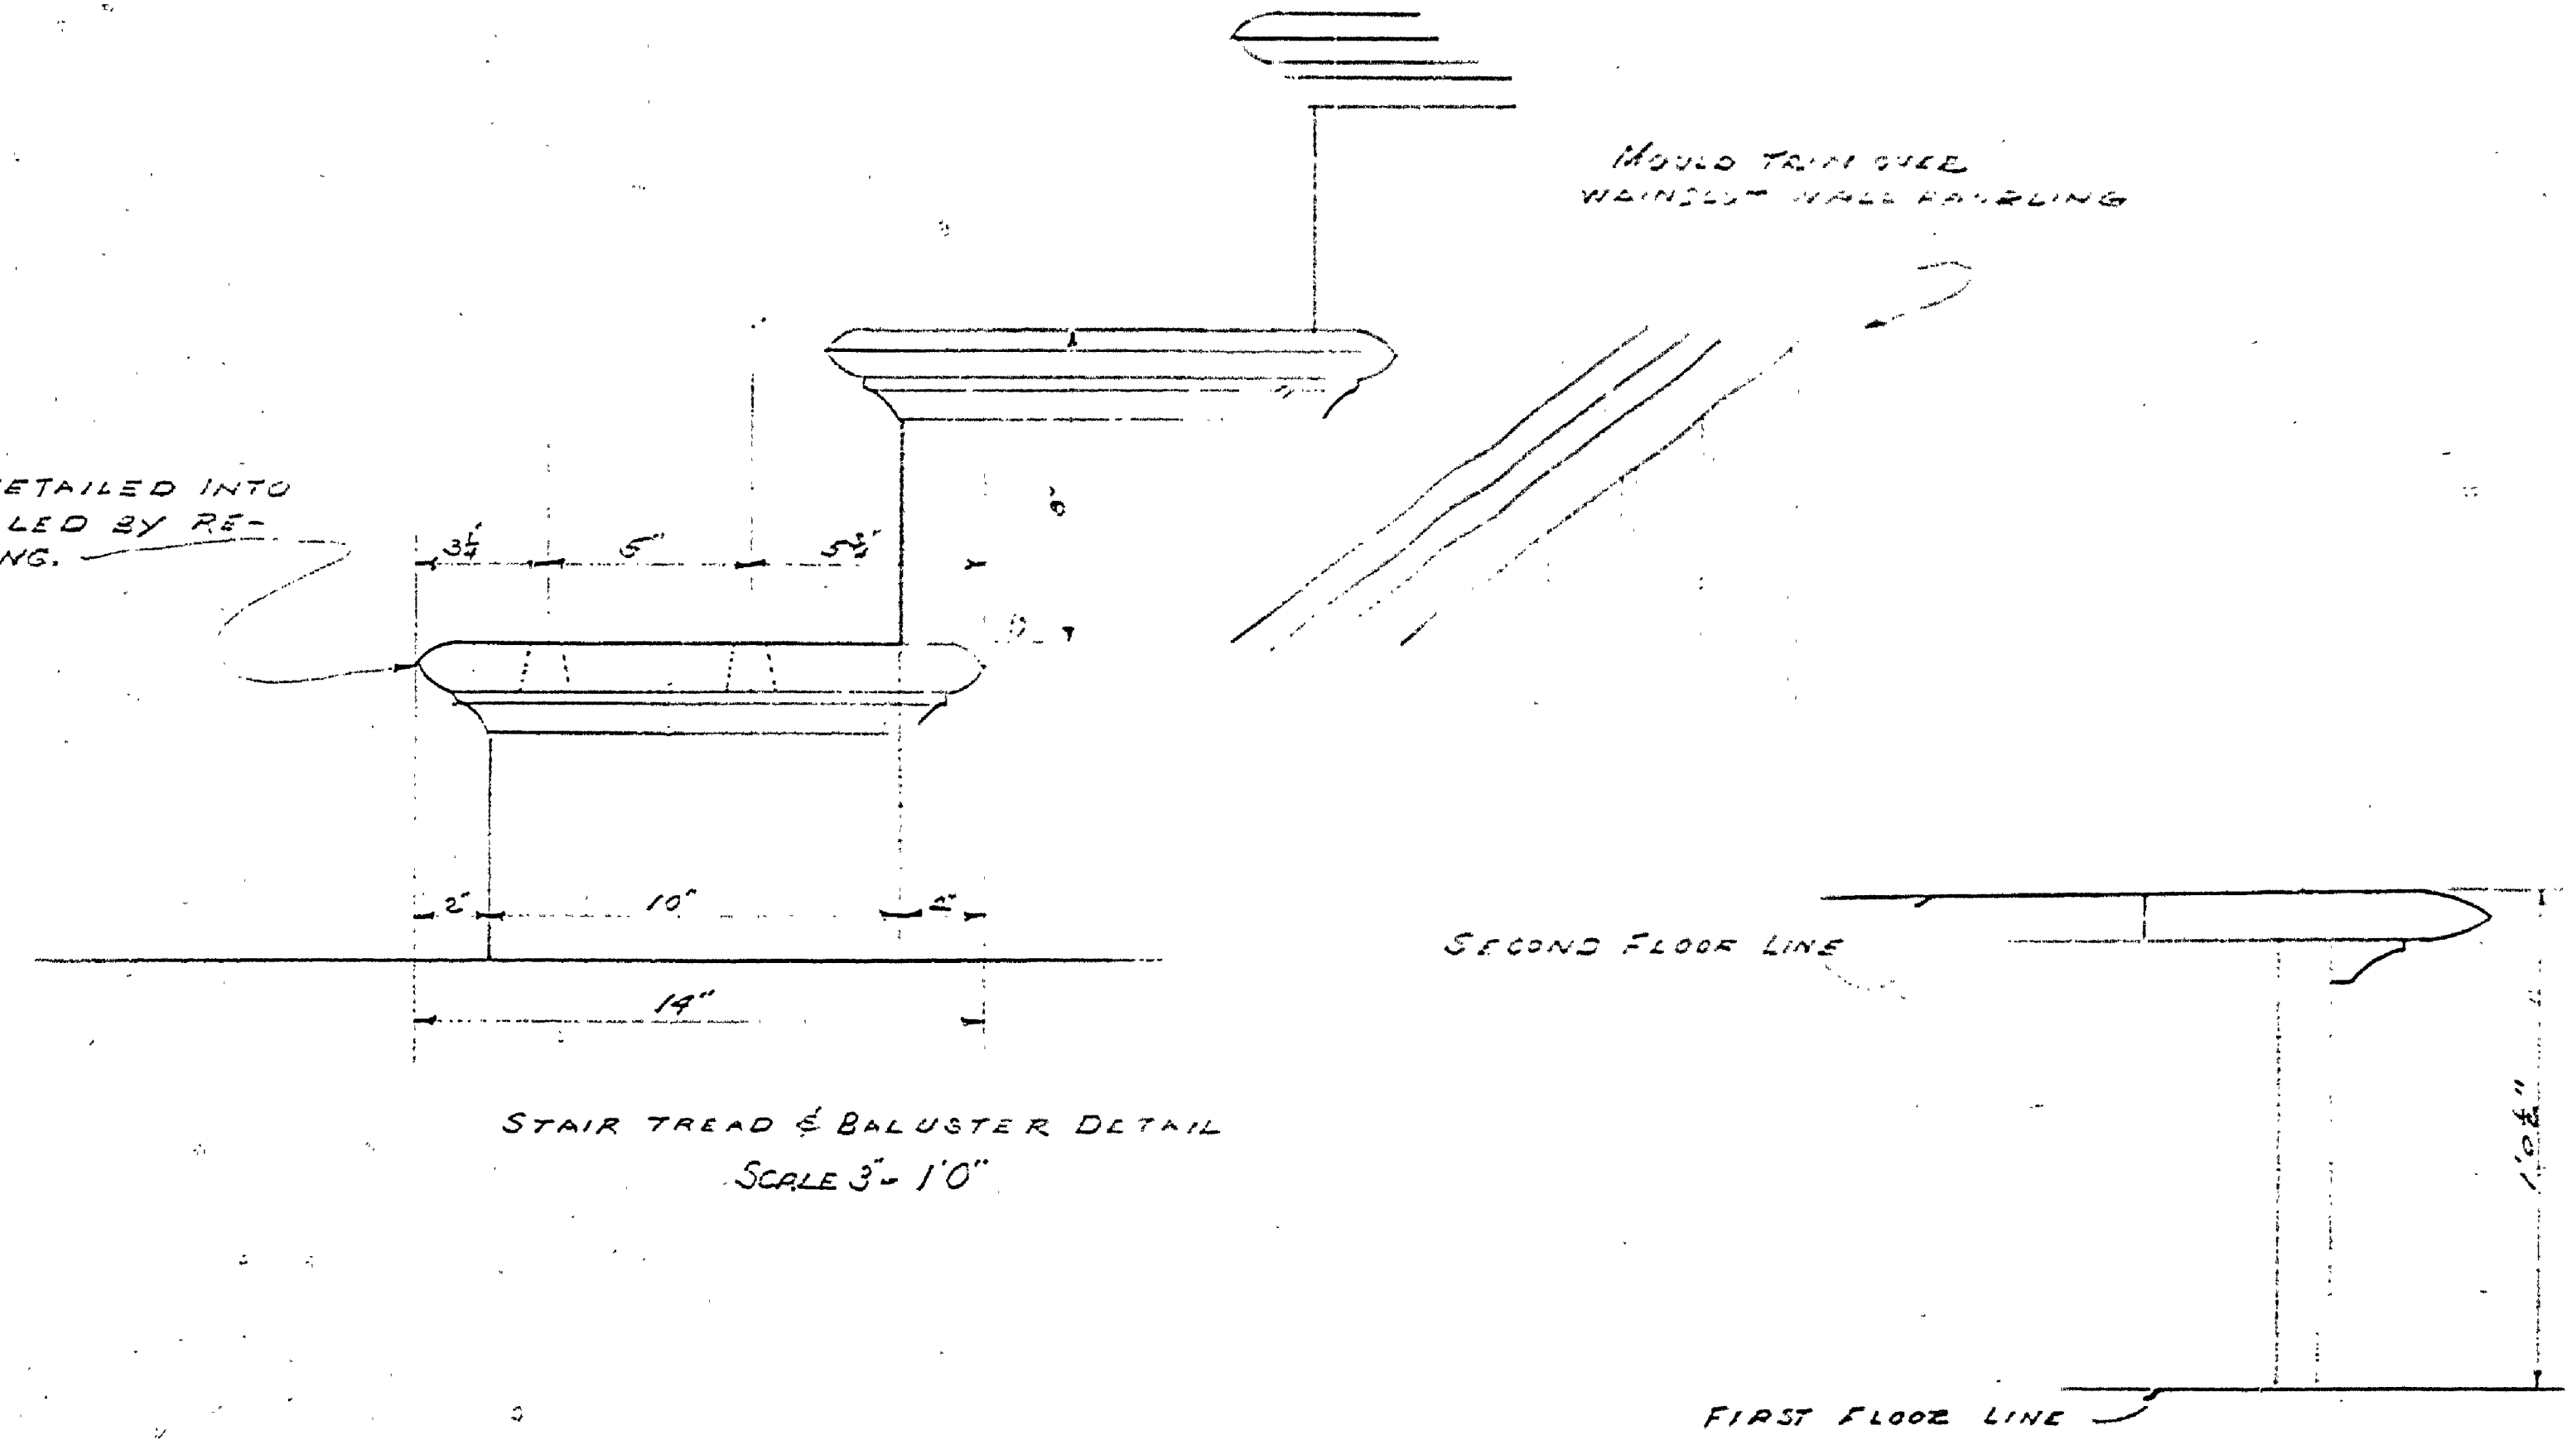
STAIR TREAD & BALUSTER DETAIL  
SCALE 3\"/>

BALUSTER DOVETAILED INTO TREAD, CONCEALED BY RETURN OF MOULDING.
